SMT10-04-133-226 (41T) Linear Actuator By Sterling Motion Block Replacement

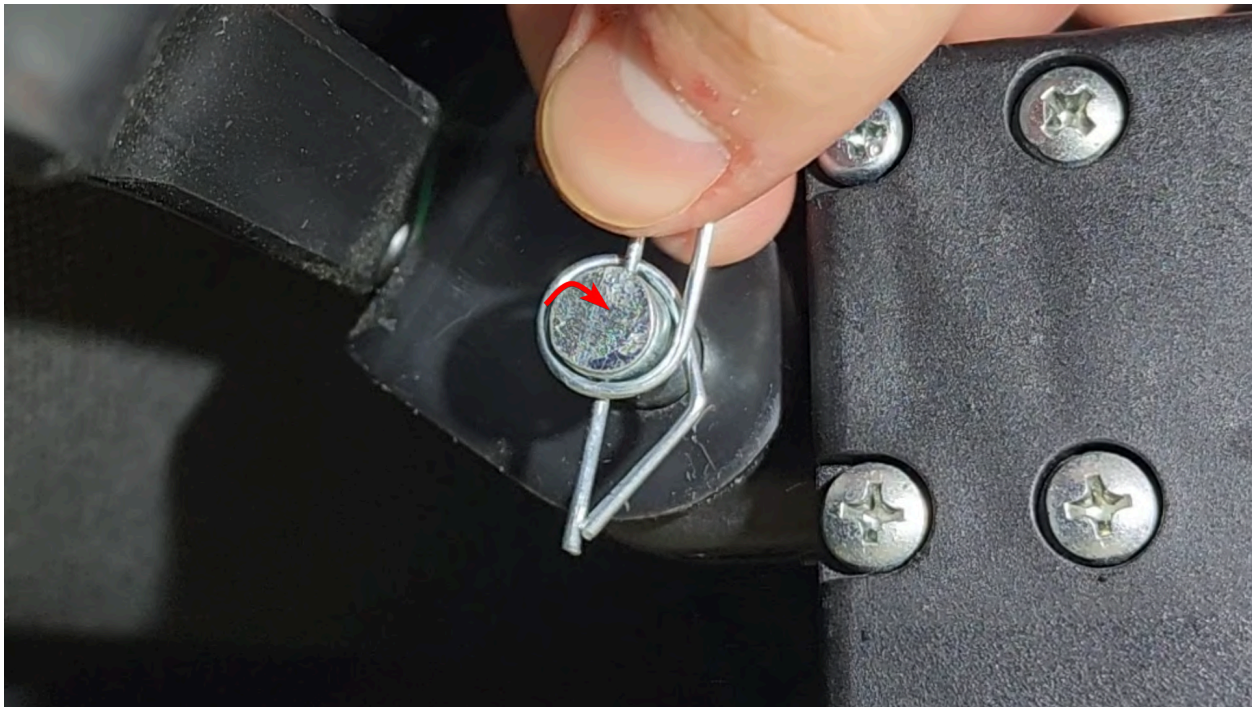
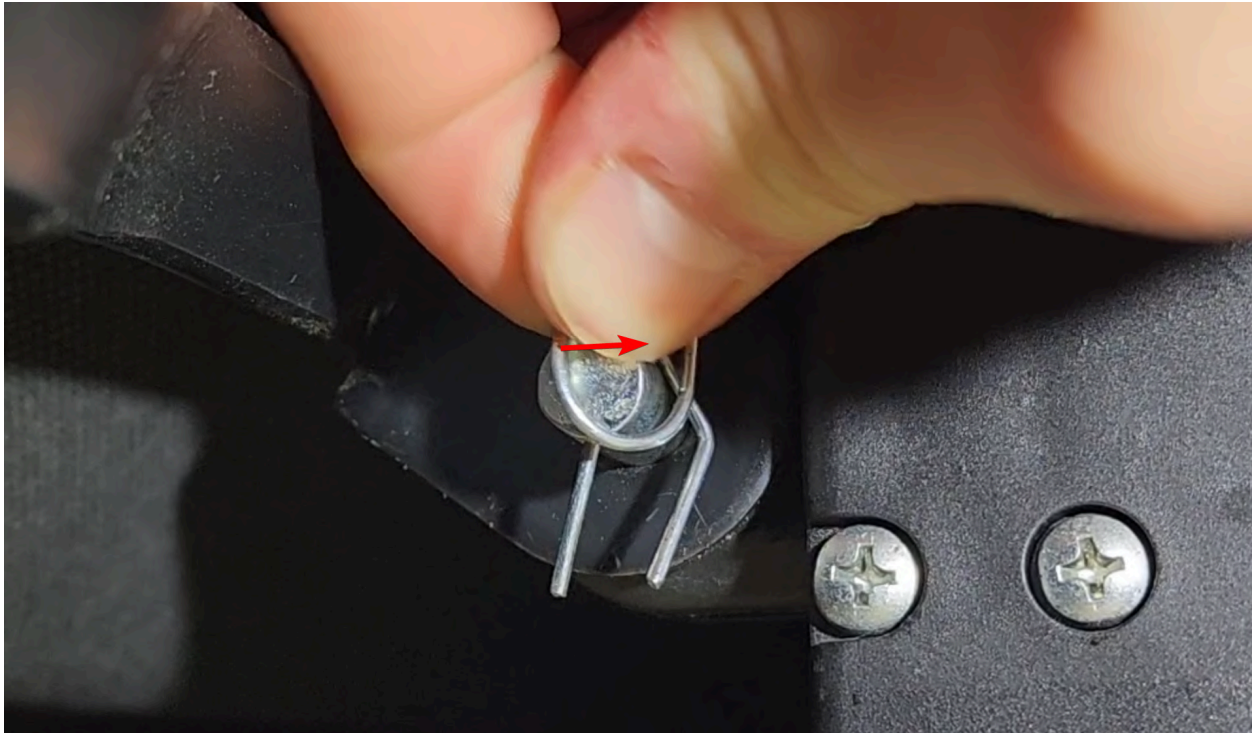
1. Before removing anything, make sure to press the button to move the recliner to the reclined position. Regardless of the chair not operating, this will help to remove the block later. Unplug the couch from the wall after this.
2. Ensure the 2 power cables are unplugged from the motor. There are small clips that hinge onto them to prevent them from coming loose. Undo the clips and unplug the two cables.
3. Undo the ring pin that is holding the main pin in place. This is best done by rotating it like this to slide the ring off the top of the main pin.

4. Pull the retaining ring pin out of the chair.
5. Assuming the block is broken, the front one will not be attached to the motor assembly. The same steps apply to remove the retaining pin and main pin.
6. Remove assembly from the chair.

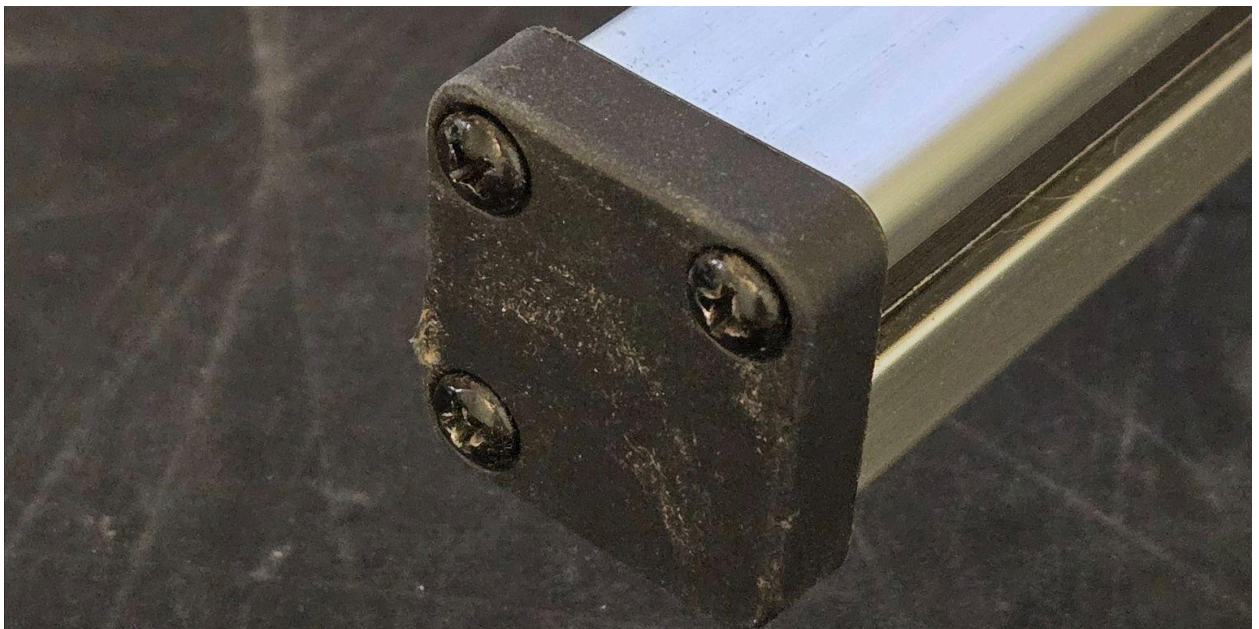
17. Place the housing cover back on and tighten all of the fasteners again. (Reverse of step 2)
18. Reattach the cap at the end of the aluminum rail.

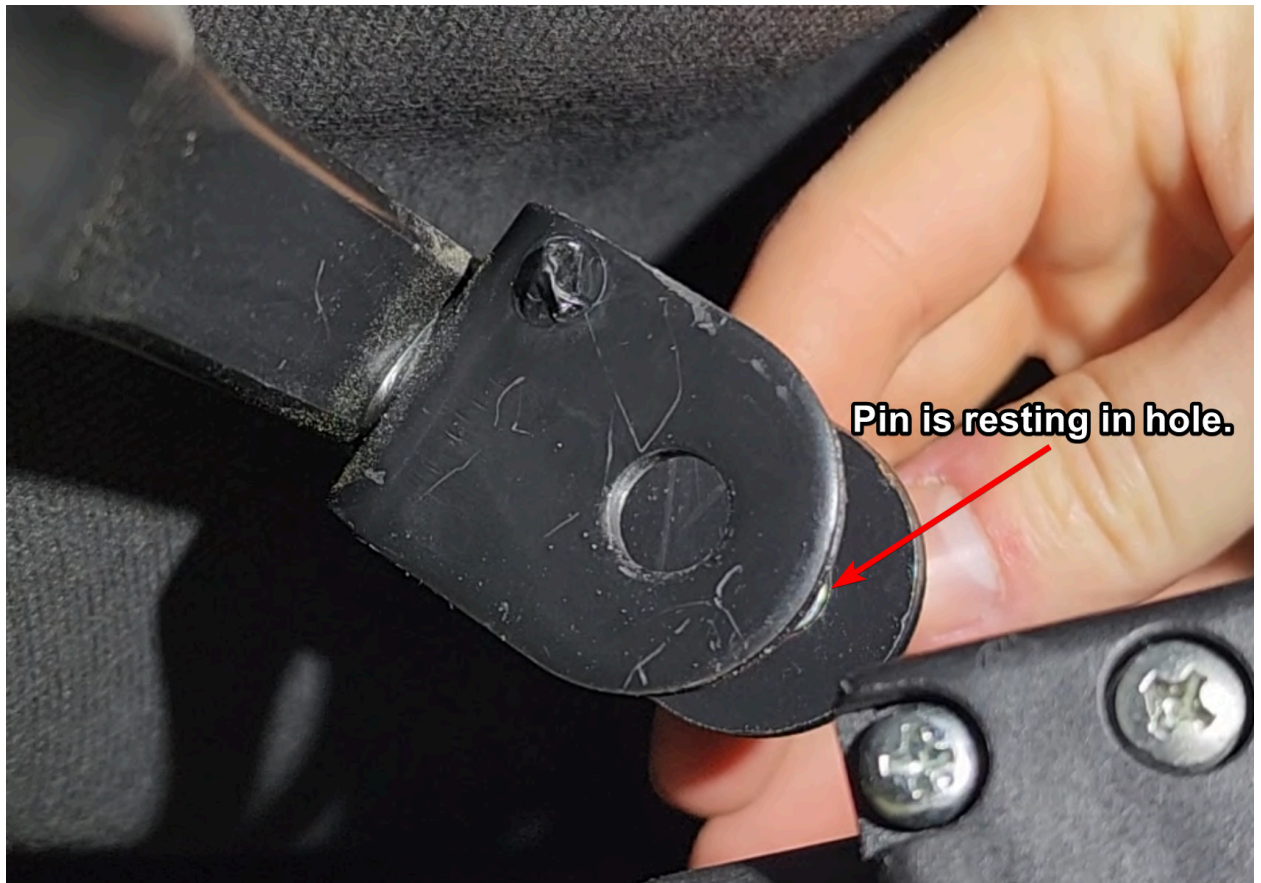
1. Before attaching either of the pins, the couch should still be unplugged from the wall.
2. Plug the two couch cables back into the motor.
3. Start with the rear pin, where the motor is. I found that resting the pin in the hole very shallowly helped with getting it through the two plates and assembly.

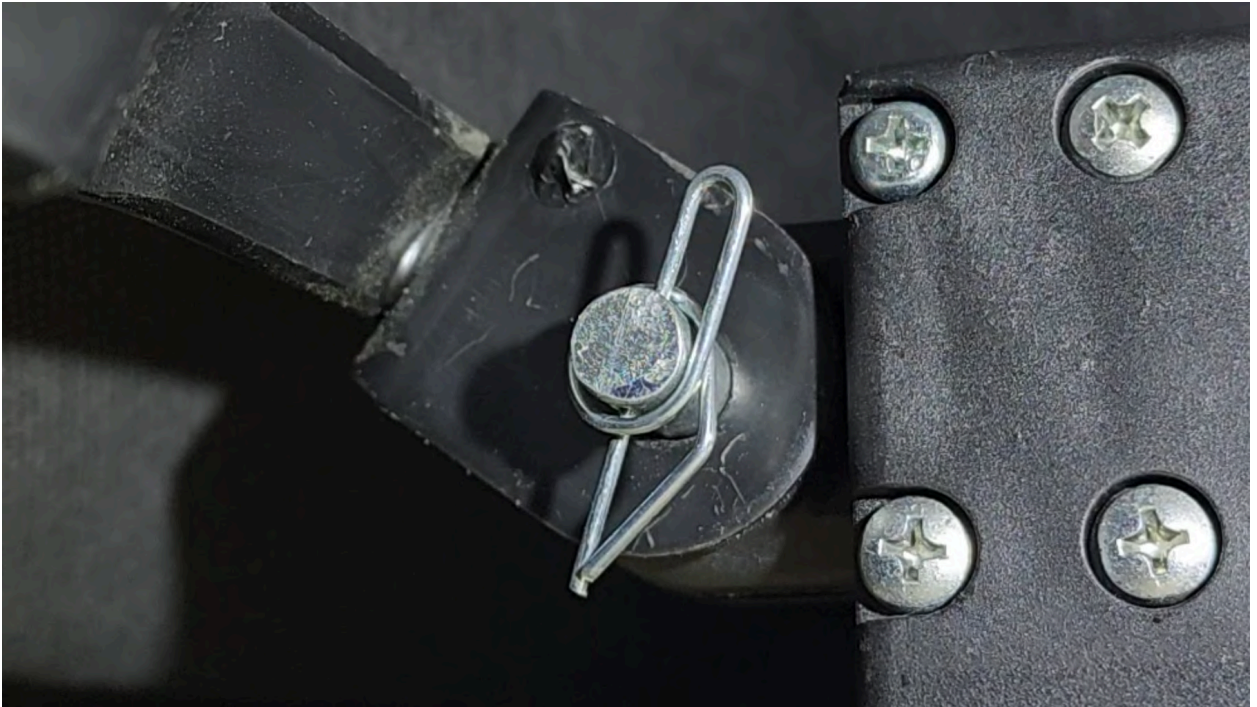
6. Twist the retaining ring pin so that the ring snaps into the locked position on the main pin. It should look like this when complete.

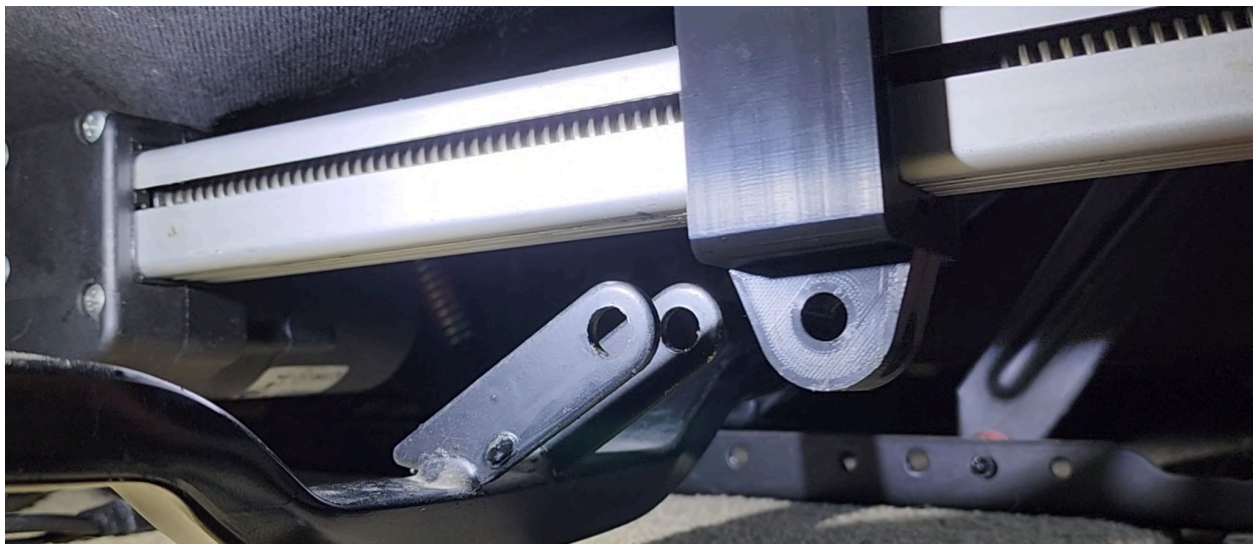
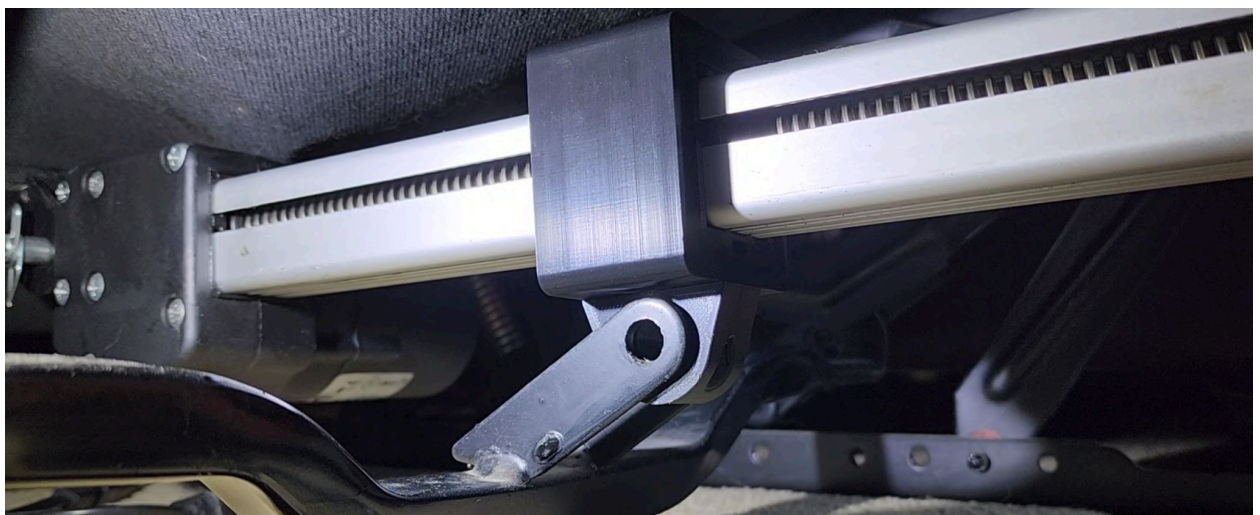
7. Plug the couch into the wall.
 - a. Due to the moving position of the recliner (assuming you are laying under it), the block will not line up with the couch recliner holes at all.
 - b. Use the recliner buttons to move the block to the correct position for inserting the main pin.
