DP03-122-220-05 Linear Actuator Block Replacement

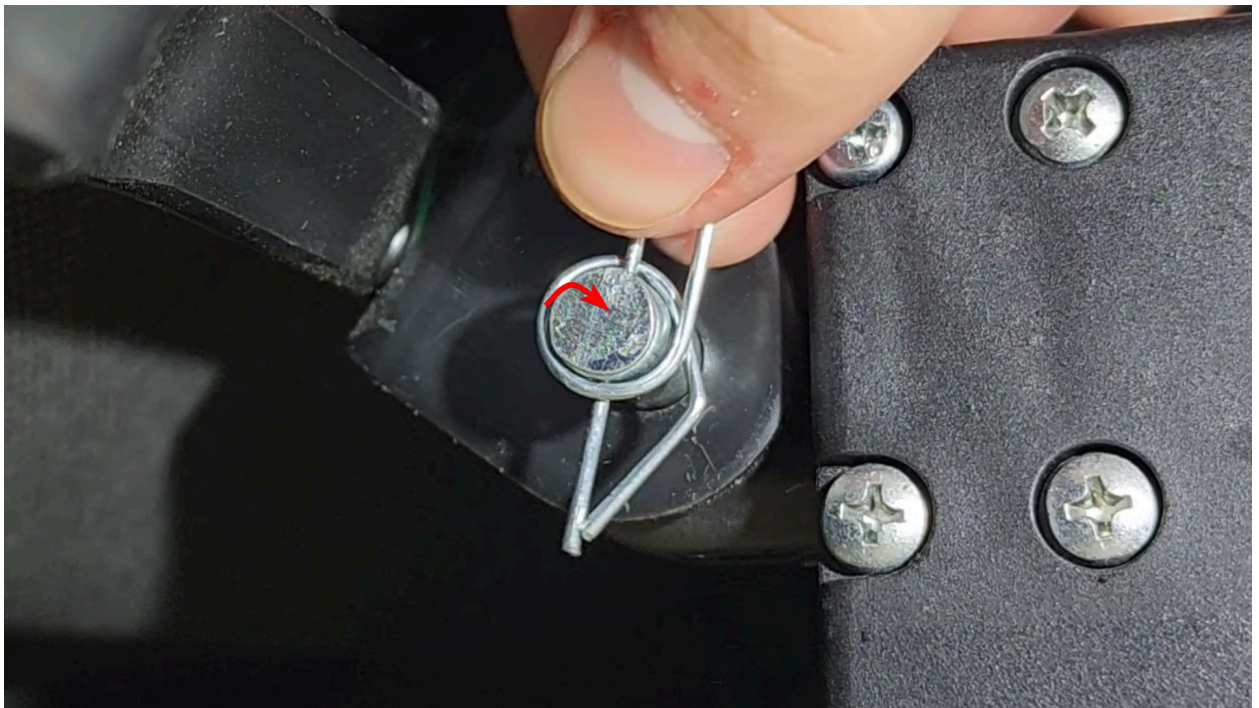
1. Before removing anything, make sure to press the button to move the recliner to the reclined position. Regardless of the chair not operating, this will help to remove the block later. Unplug the couch from the wall after this.
2. Ensure the 2 power cables are unplugged from the motor. There are small clips that hinge onto them to prevent them from coming loose. Undo the clips and unplug the two cables.
3. Undo the ring pin that is holding the main pin in place. This is best done by rotating it like this to slide the ring off the top of the main pin.

4. Pull the retaining ring pin out of the chair.
5. Assuming the block is broken, the front one will not be attached to the motor assembly. The same steps apply to remove the retaining pin and main pin.
6. Remove assembly from the chair.

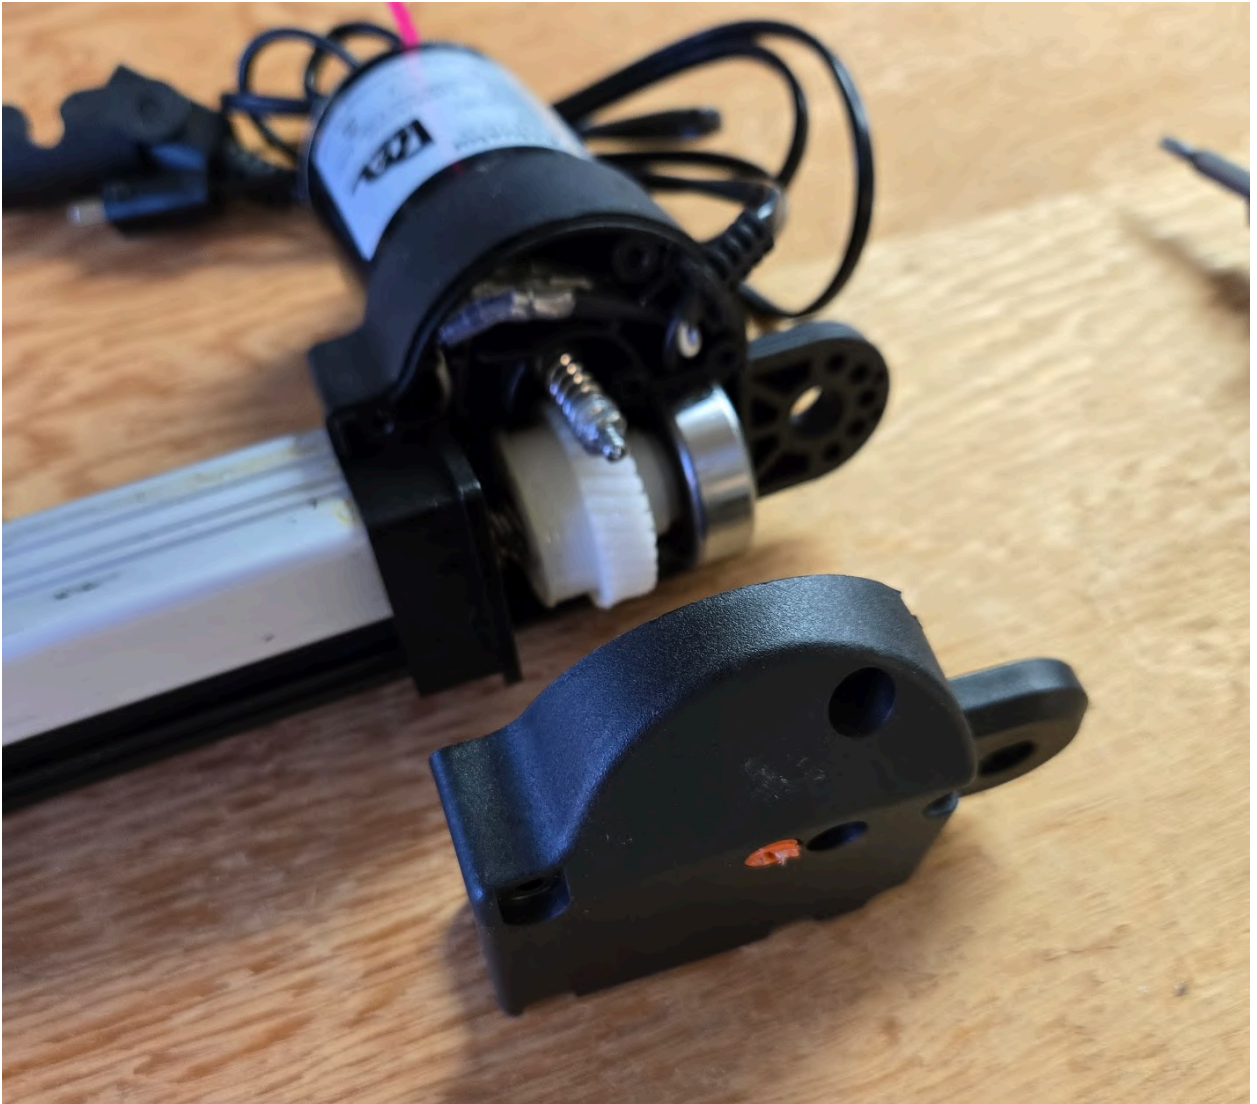
3. Remove gearbox cover. There are no clips holding it in place, only the fasteners that were just removed. Here is what that looks like:

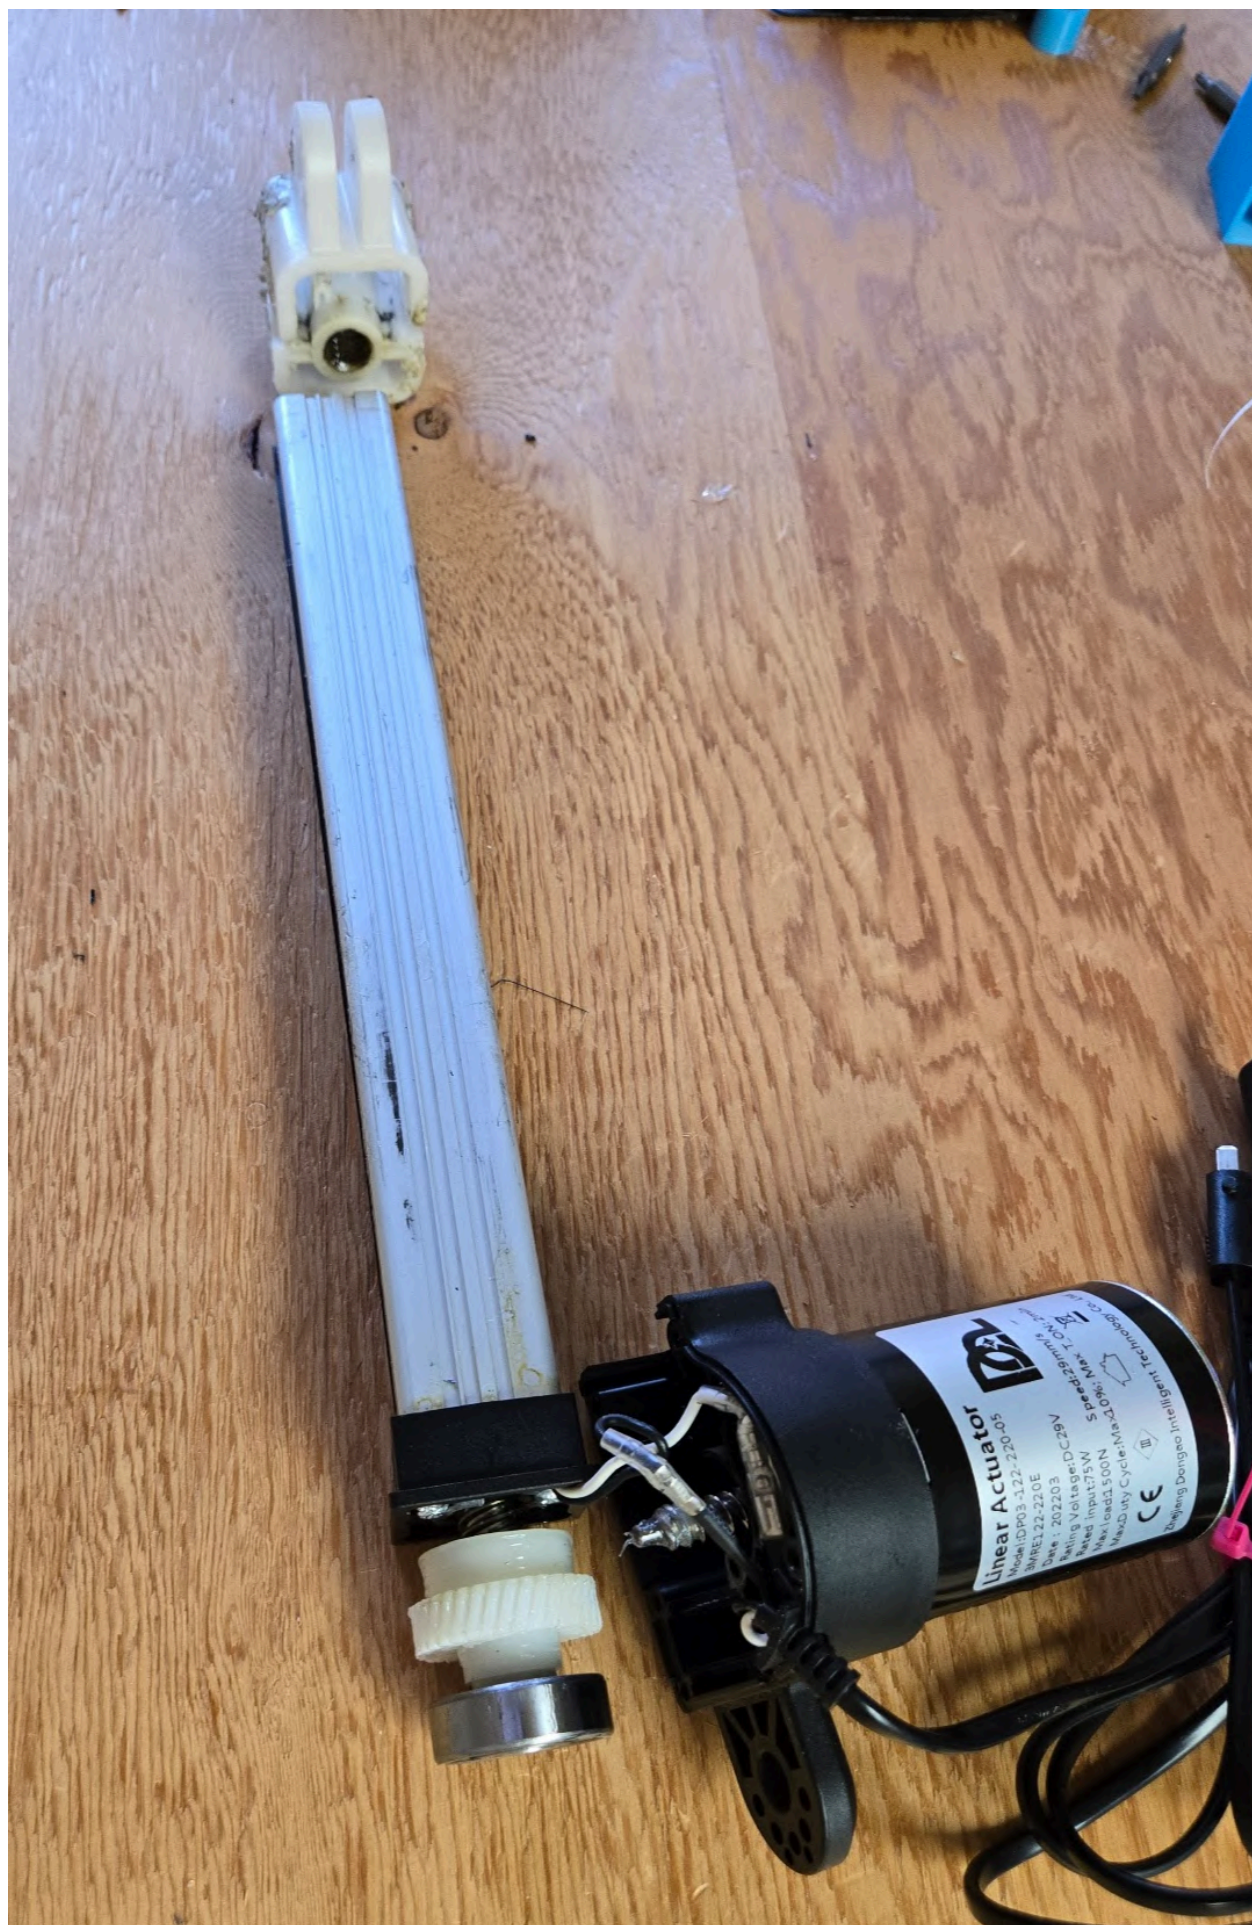
6. Twist the plastic gear counter-clockwise (the bearing pictured above is the top for reference) and either 2 things will happen
 - a. The broken plastic block will slide to the end of the aluminum rail and you can take it off.
 - b. The lead screw comes out and the plastic block doesn't move. If this happens keep going in the same direction, then push the lead screw down back into the aluminum rail. This will push the plastic block off the end. Repeat as many times as necessary to remove the block.

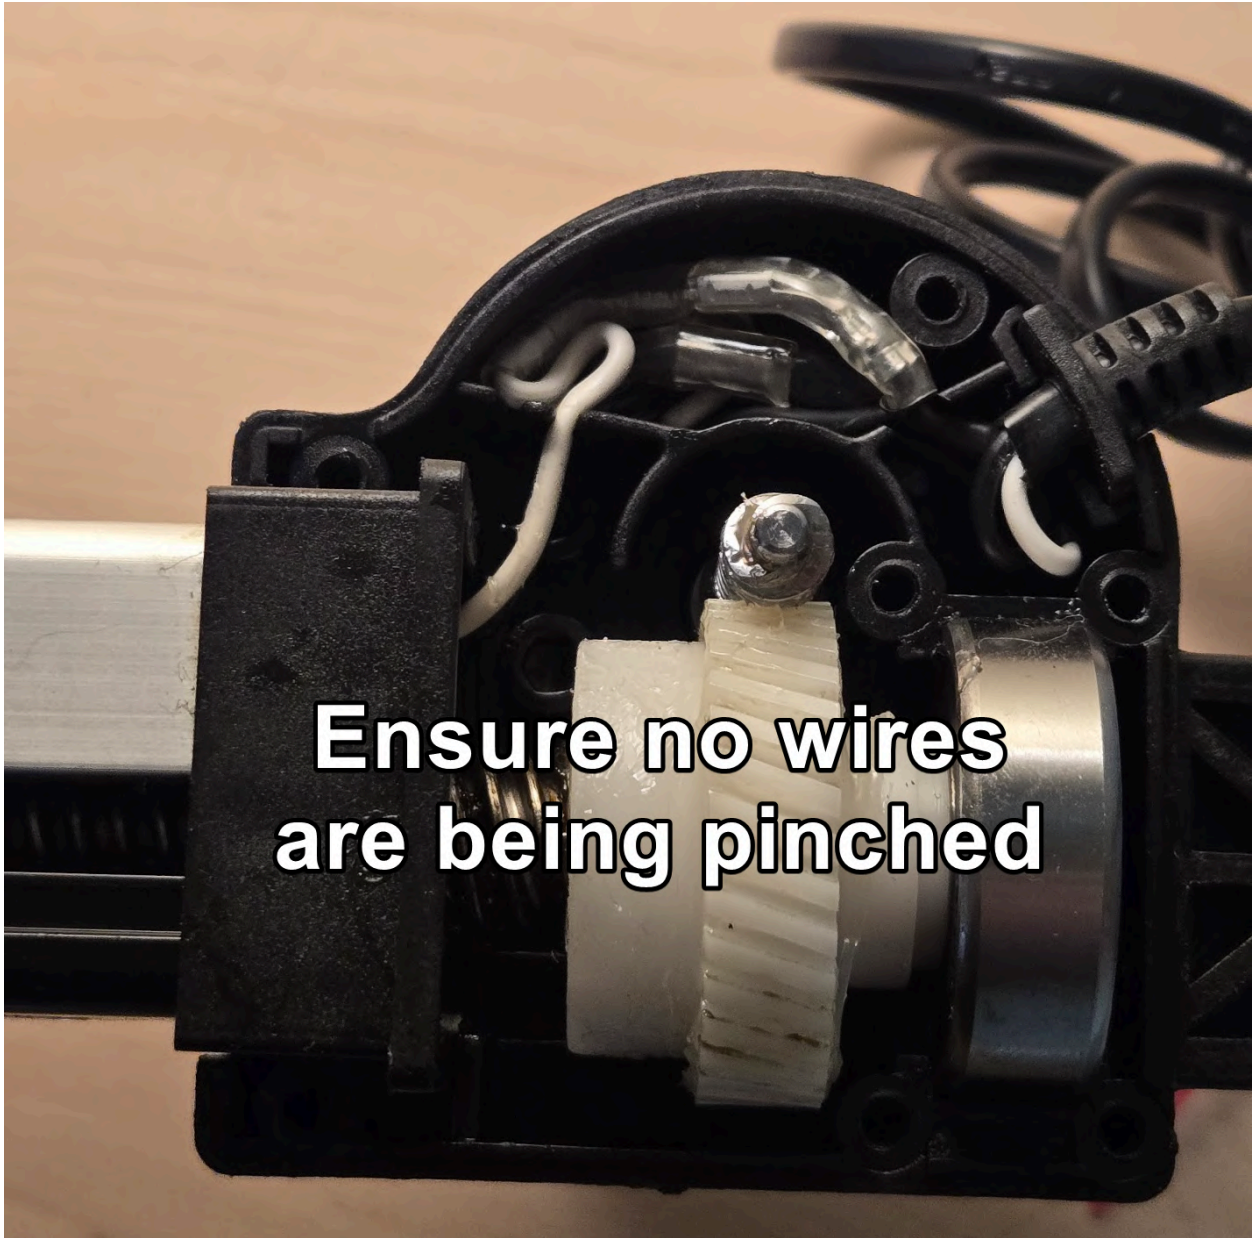
14. Get the wiring to fit back into the empty space made for it, and ensure the cable strain relief is lined up with the housing case.

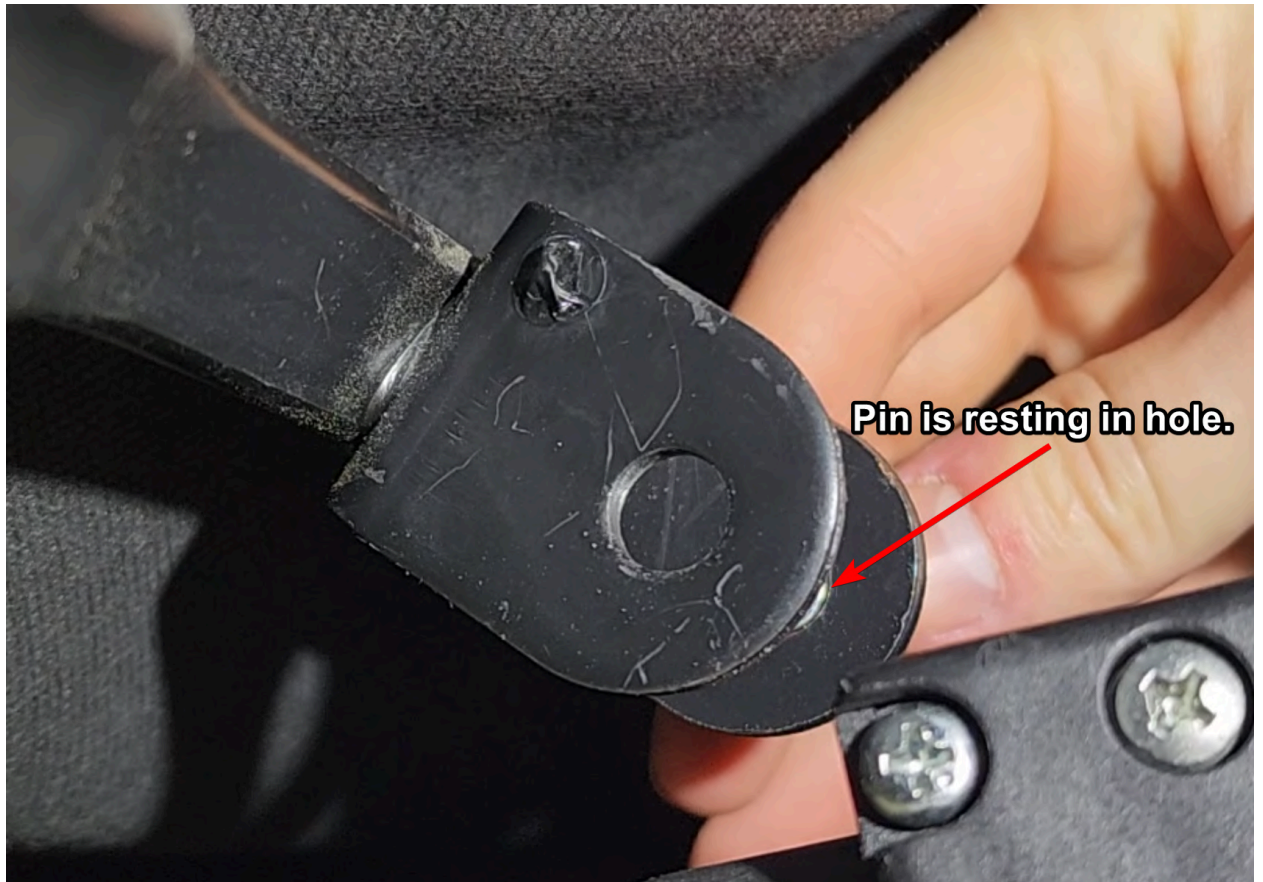
1. Before attaching either of the pins, the couch should still be unplugged from the wall.
2. Plug the two couch cables back into the motor.
3. Start with the rear pin, where the motor is. I found that resting the pin in the hole very shallowly helped with getting it through the two plates and assembly.

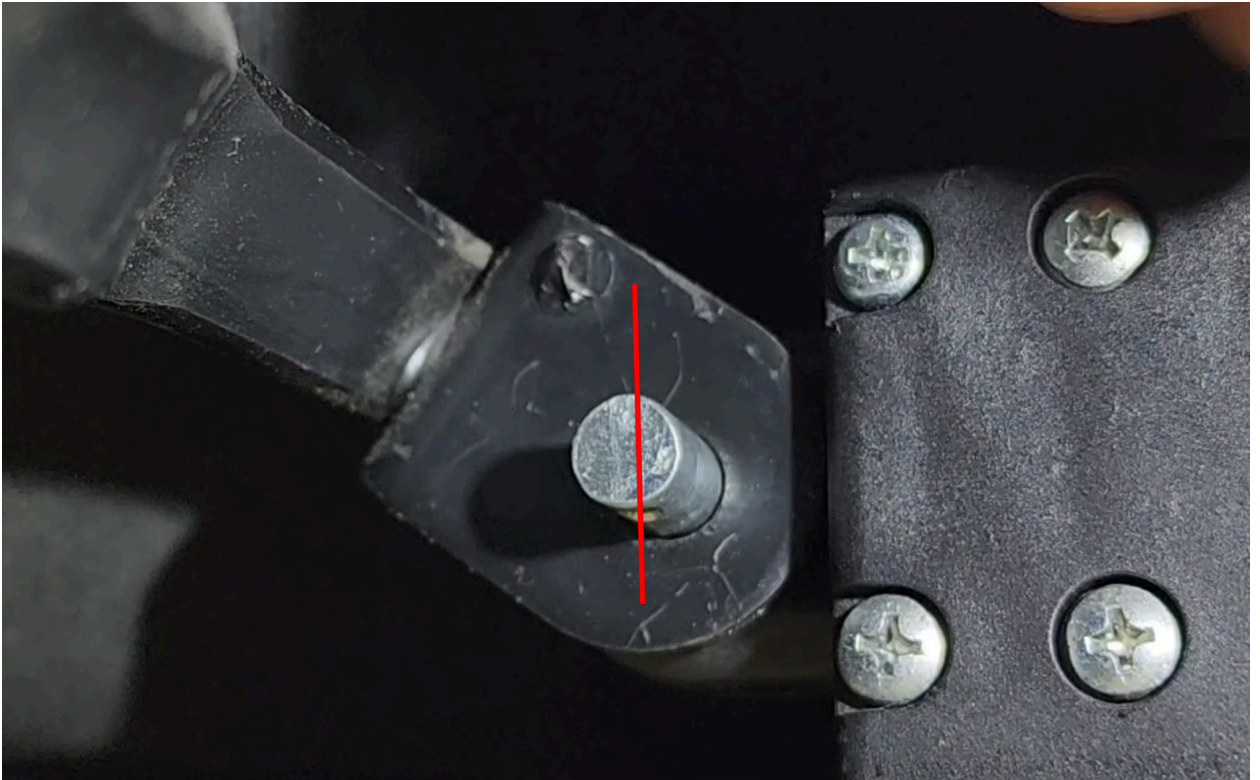
4. Make sure the hole in the main pin is roughly up/down so that the retaining ring pin can be pushed in easily.

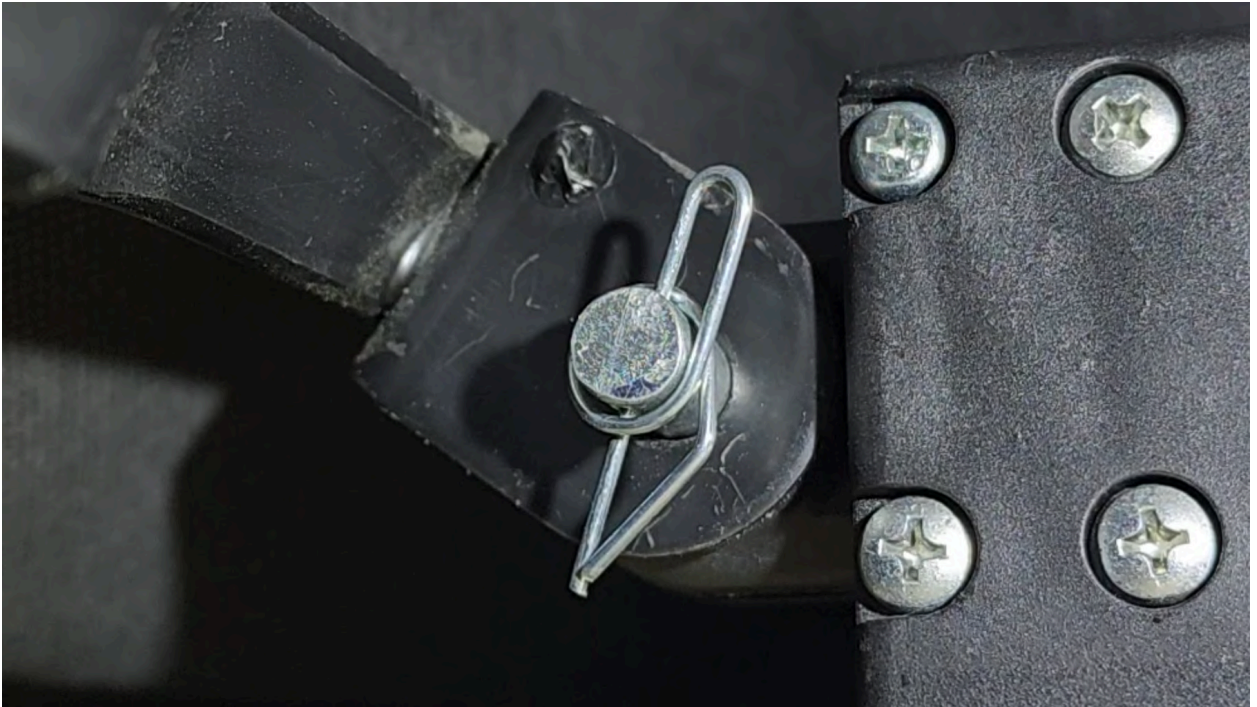
6. Twist the retaining ring pin so that the ring snaps into the locked position on the main pin. It should look like this when complete.

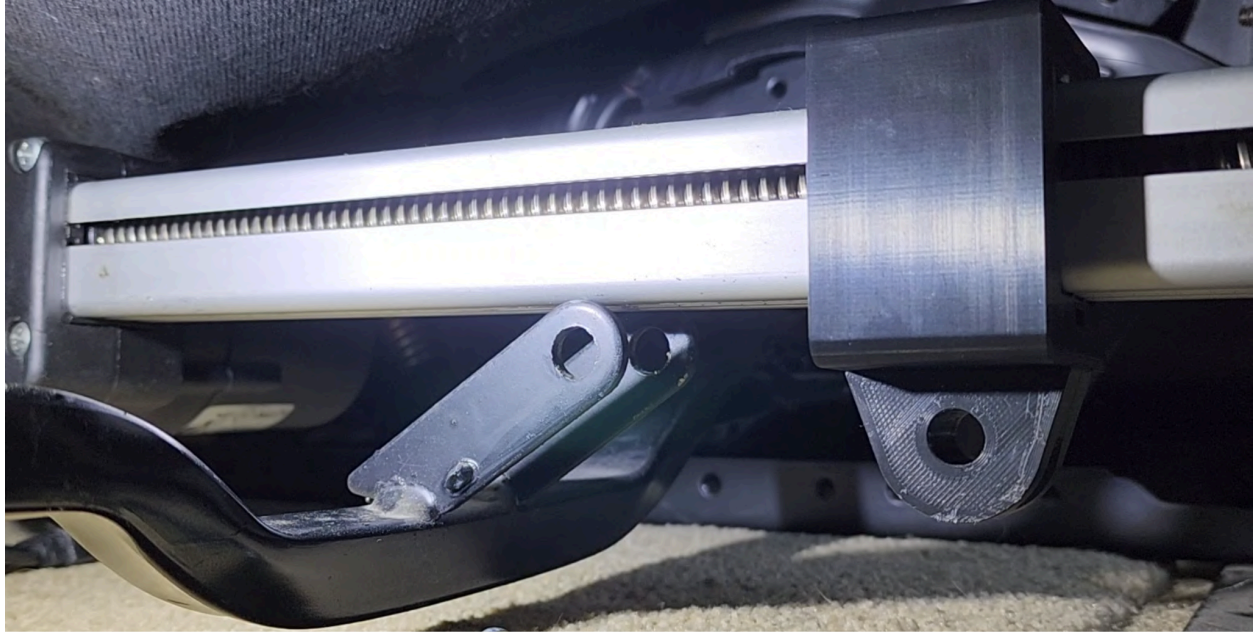
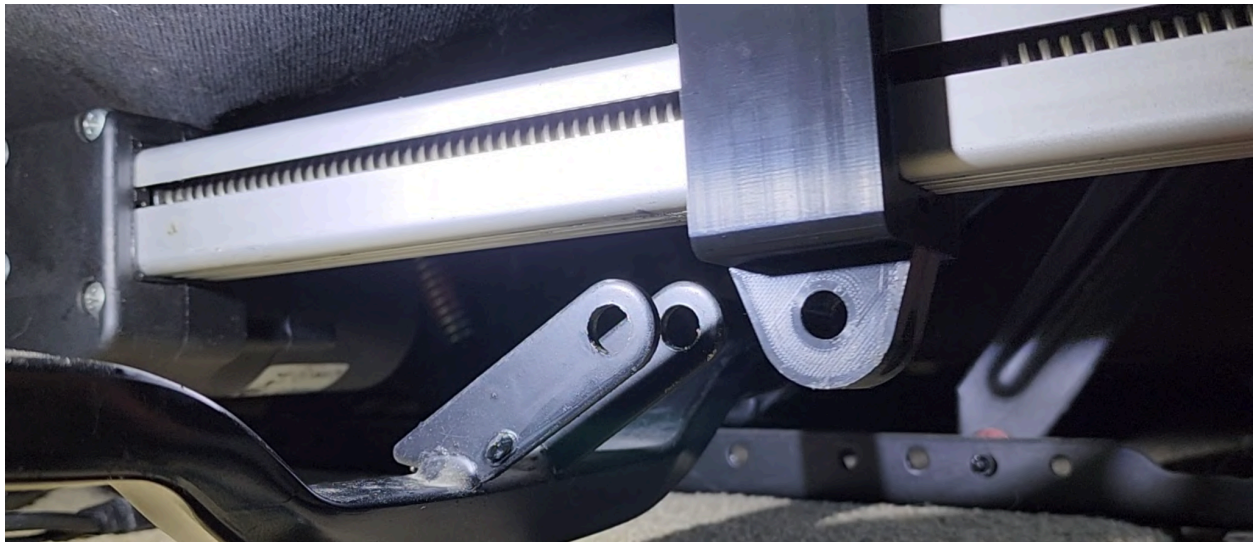
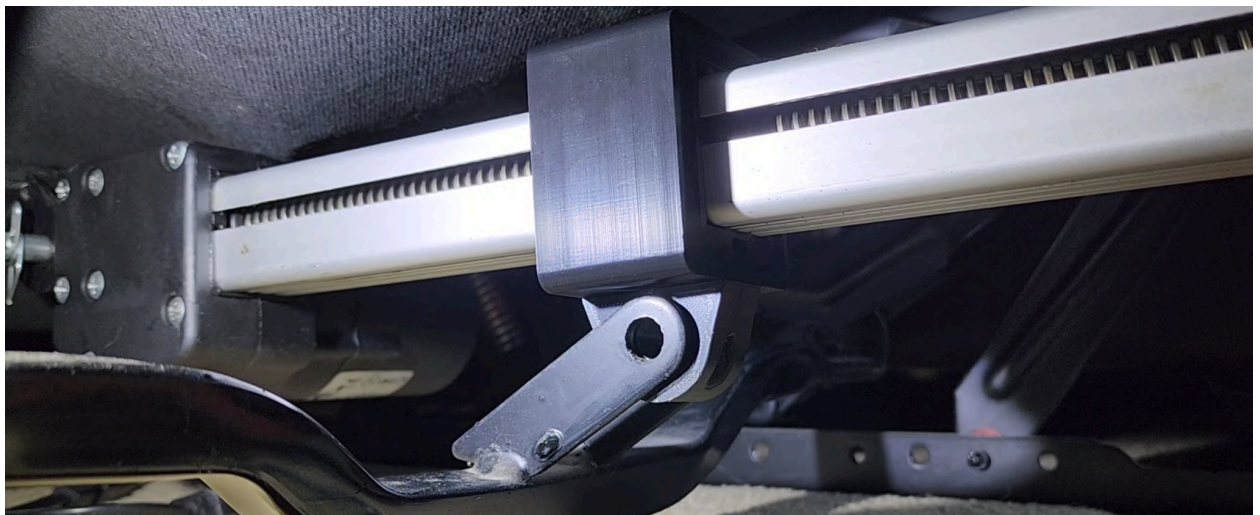
7. Plug the couch into the wall.
 - a. Due to the moving position of the recliner (assuming you are laying under it), the block will not line up with the couch recliner holes at all.
 - b. Use the recliner buttons to move the block to the correct position for inserting the main pin.
