MARUNI XYA5-2 Linear Actuator Block Replacement

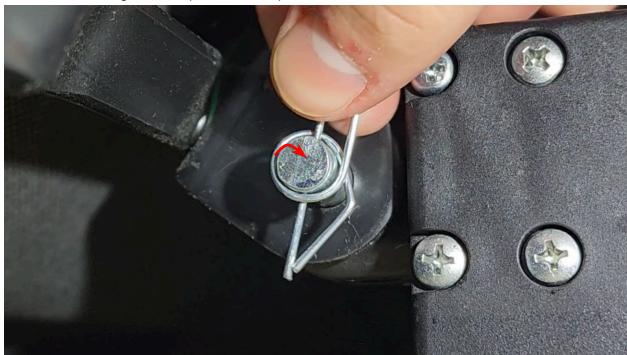
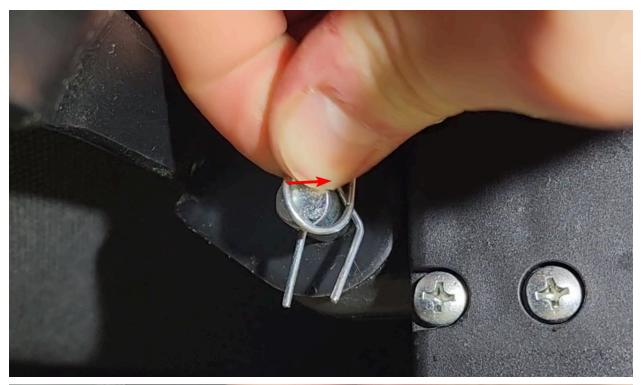
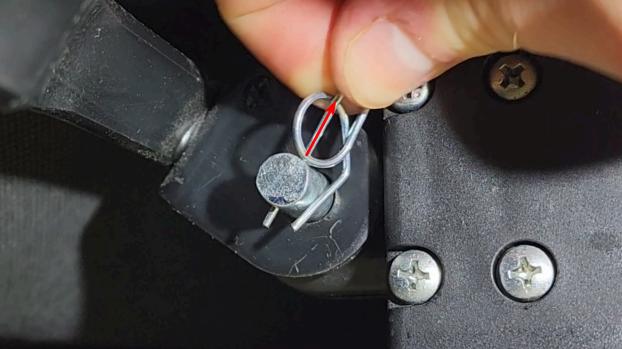
- 1. Before removing anything, make sure to press the button to move the recliner to the reclined position. Regardless of the chair not operating, this will help to remove the block later. Unplug the couch from the wall after this.
- 2. Ensure the 2 power cables are unplugged from the motor. There are small clips that hinge onto them to prevent them from coming loose. Undo the clips and unplug the two cables.
- 3. Undo the ring pin that is holding the main pin in place. This is best done by rotating it like this to slide the ring off the top of the main pin.

- 4. Pull the retaining ring pin out of the chair.
- 5. Assuming the block is broken, the front one will not be attached to the motor assembly. The same steps apply to remove the retaining pin and main pin.
- 6. Remove assembly from the chair.

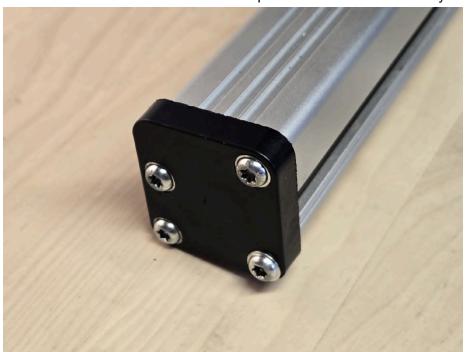
1. Remove the 4 small screws from the cap on the end of the assembly.

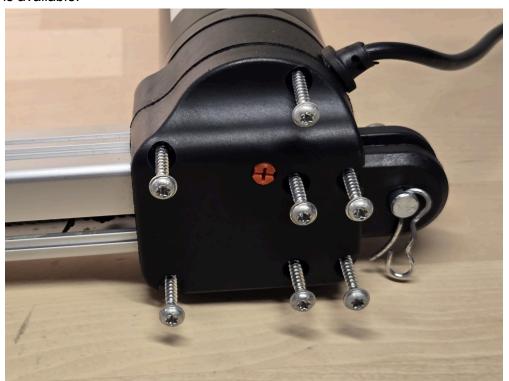
2. Remove 7 screws. These screws are quite long, I would recommend a cordless drill if it is available.

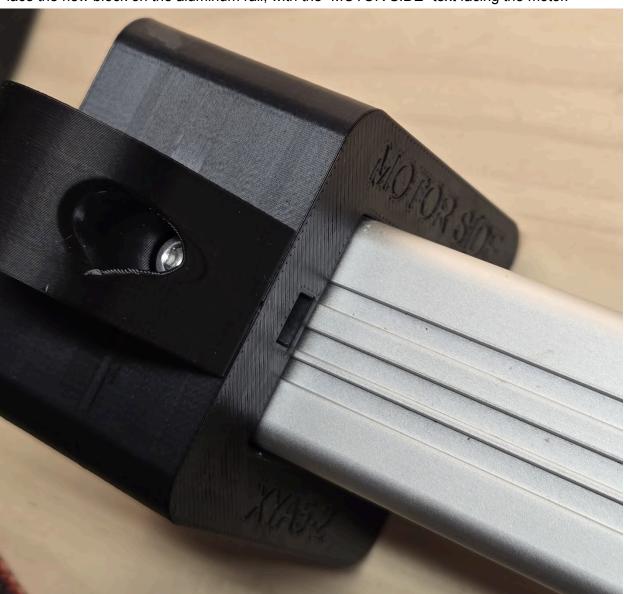
- b. The lead screw comes out and the plastic block doesn't move. If this happens keep going in the same direction, then push the lead screw down back into the aluminum rail. This will push the plastic block off the end. Repeat as many times as necessary to remove the block.
- 7. (Optional) At this time if you have some grease, you can apply it to the threads on the block so they will be spread around by the lead screw.
- 8. Place the new block on the aluminum rail, with the "MOTOR SIDE" text facing the motor.

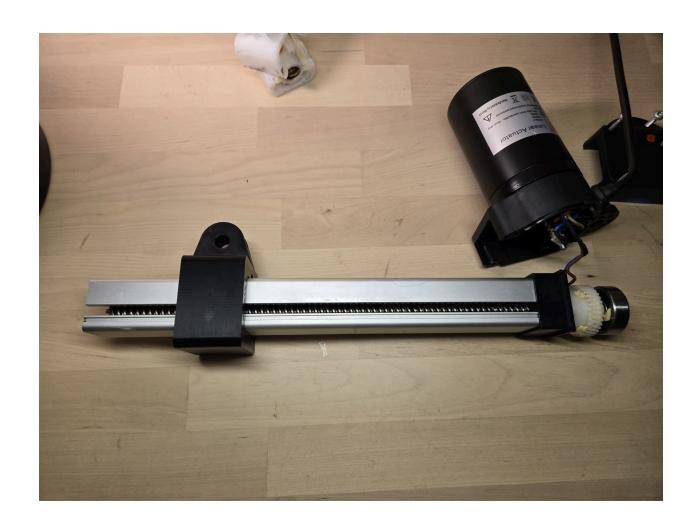
- 9. Slide the block down the aluminum rail, until it hits the lead screw.
- 10. Turn the lead screw with the plastic gear clockwise so it goes into the block.
 - a. Turning the lead screw this direction will force the plastic gear into the aluminum rail screws pictured in the photo above. To more easily screw on the block, pull the lead screw out a little to avoid this.

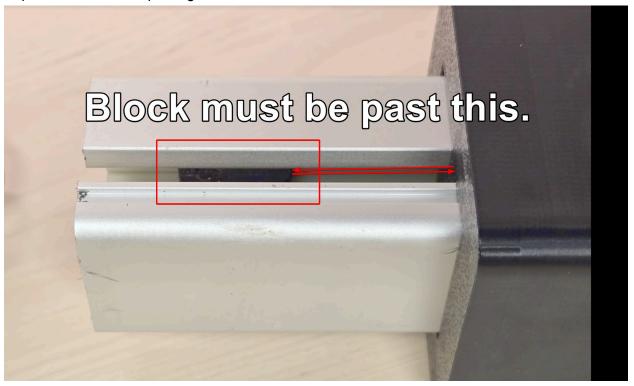
11. Ensure the block is fully on the aluminum rail. It will need to be past the limit switch that stops the motor from spinning the block off the end of the rail.

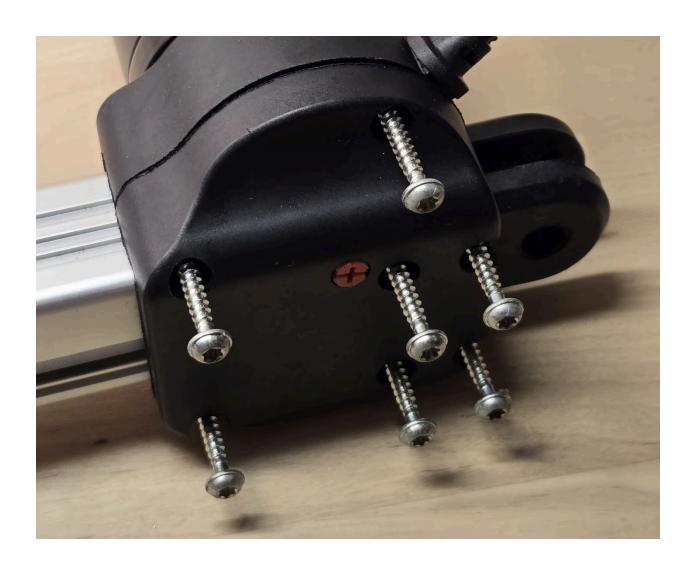
- 14. Get the wiring to fit back into the empty space made for it, and ensure the cable strain relief is lined up with the housing case.
- 15. <u>Do not pinch any of the cables in the gearbox housing.</u> Doing this can potentially damage the wires.
- 16. Place the housing cover back on and tighten all of the fasteners again. (Reverse of step 2)

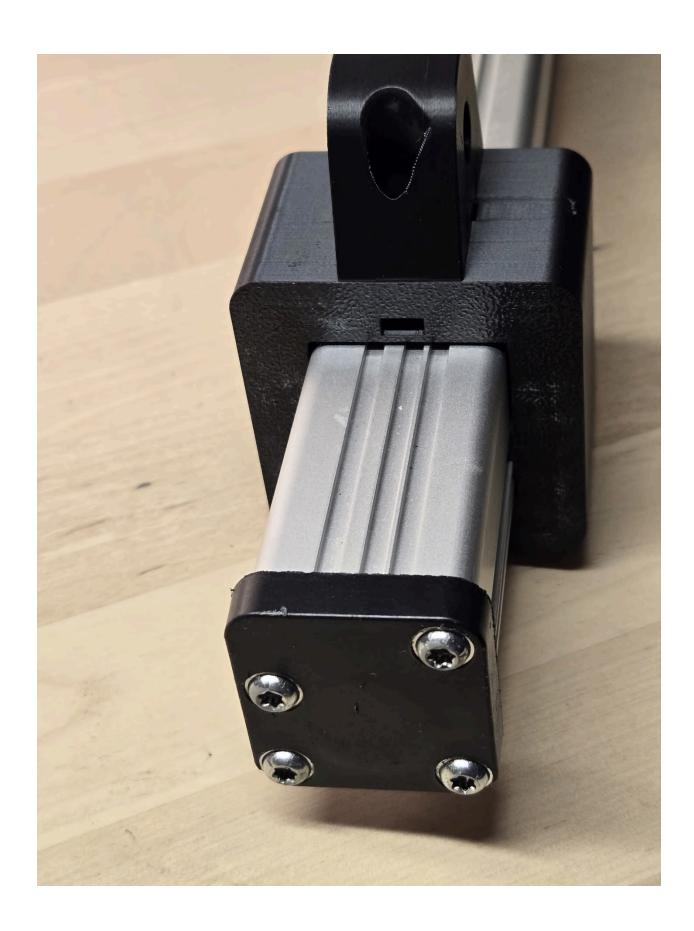
17. Reattach the cap at the end of the aluminum rail.

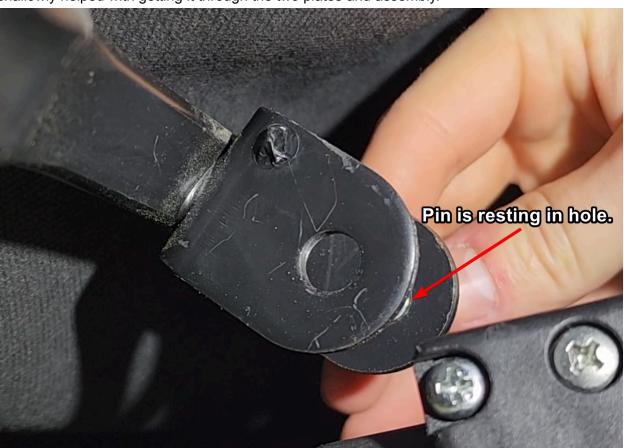
- 1. Before attaching either of the pins, the couch should still be unplugged from the wall.
- 2. Plug the two couch cables back into the motor.
- 3. Start with the rear pin, where the motor is. I found that resting the pin in the hole very shallowly helped with getting it through the two plates and assembly.

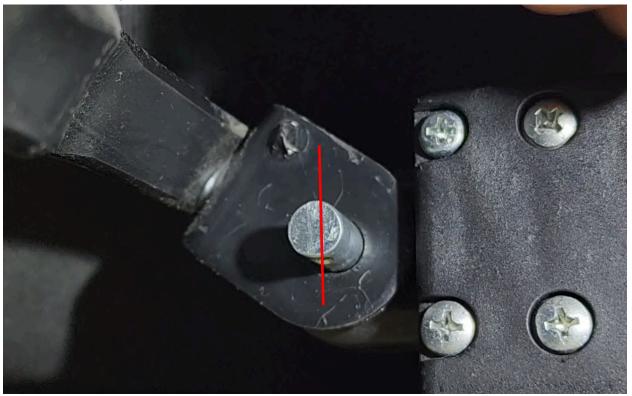
4. Make sure the hole in the main pin is roughly up/down so that the retaining ring pin can be pushed in easily.

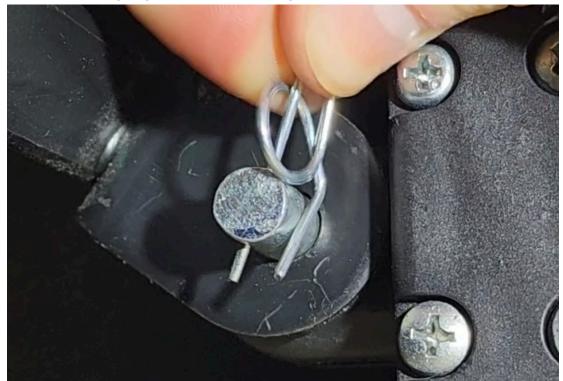
5. Push the retaining ring pin in, flat side through the hole.

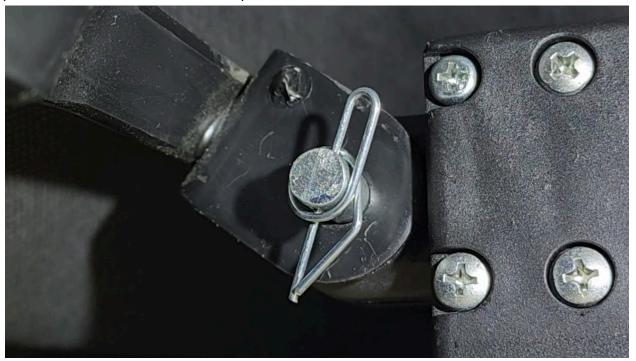
6. Twist the retaining ring pin so that the ring snaps into the locked position on the main pin. It should look like this when complete.

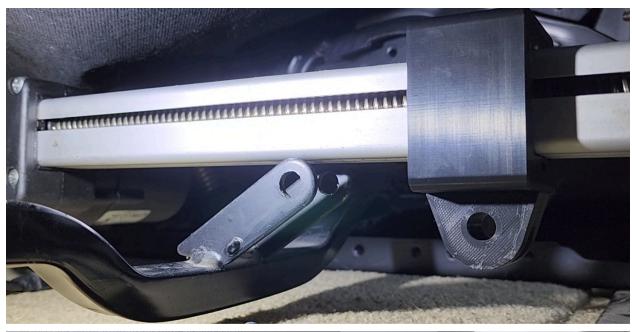
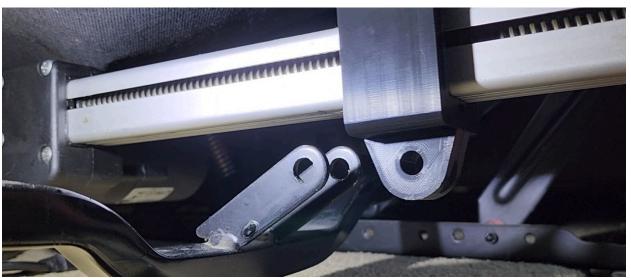
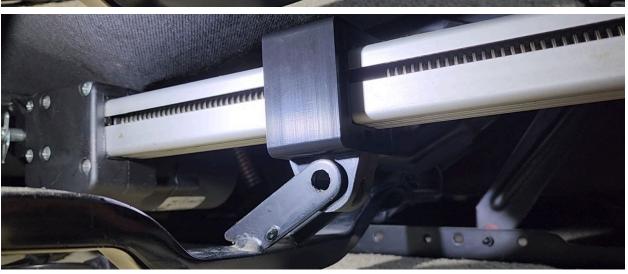
- 7. Plug the couch into the wall.
 - a. Due to the moving position of the recliner (assuming you are laying under it), the block will not line up with the couch recliner holes at all.
 - b. Use the recliner buttons to move the block to the correct position for inserting the main pin.

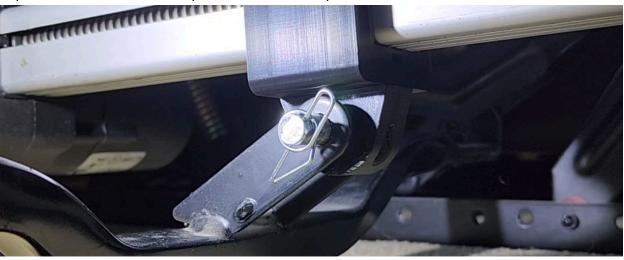
8. Repeat the same insertion steps as the back main pin.
