# Mulin ML38-025 Linear Actuator Block Replacement

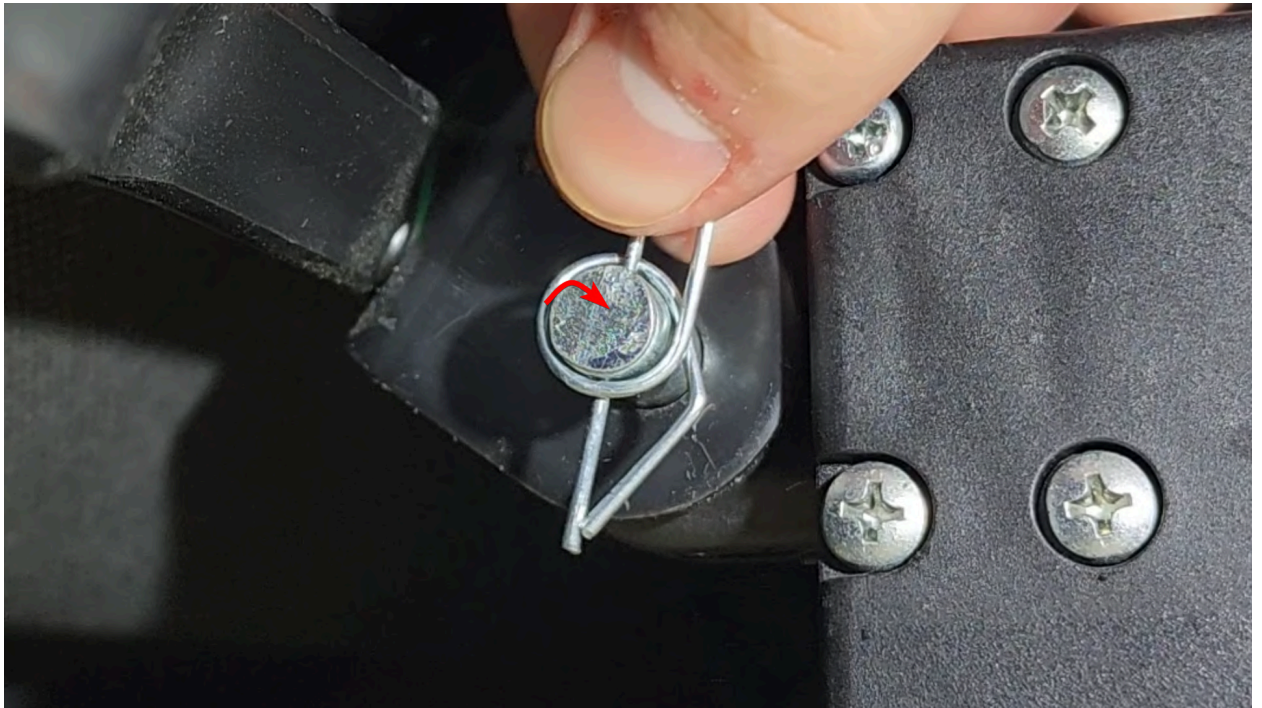
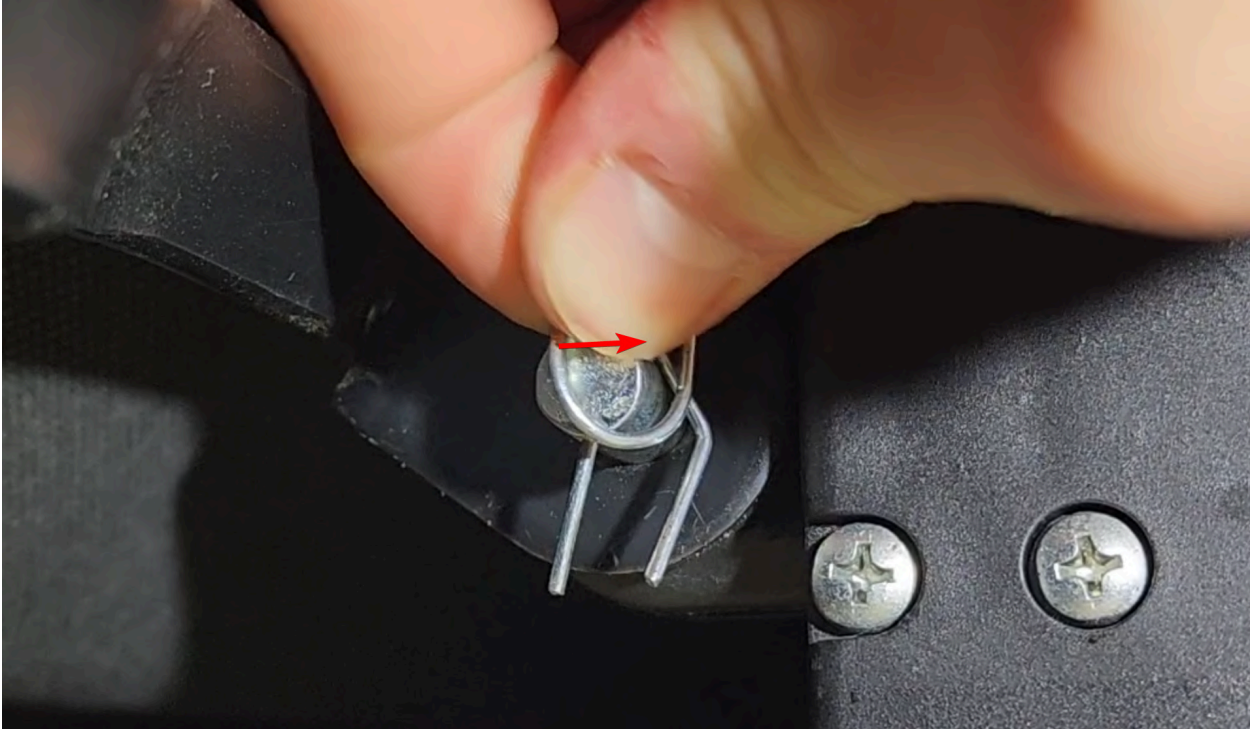
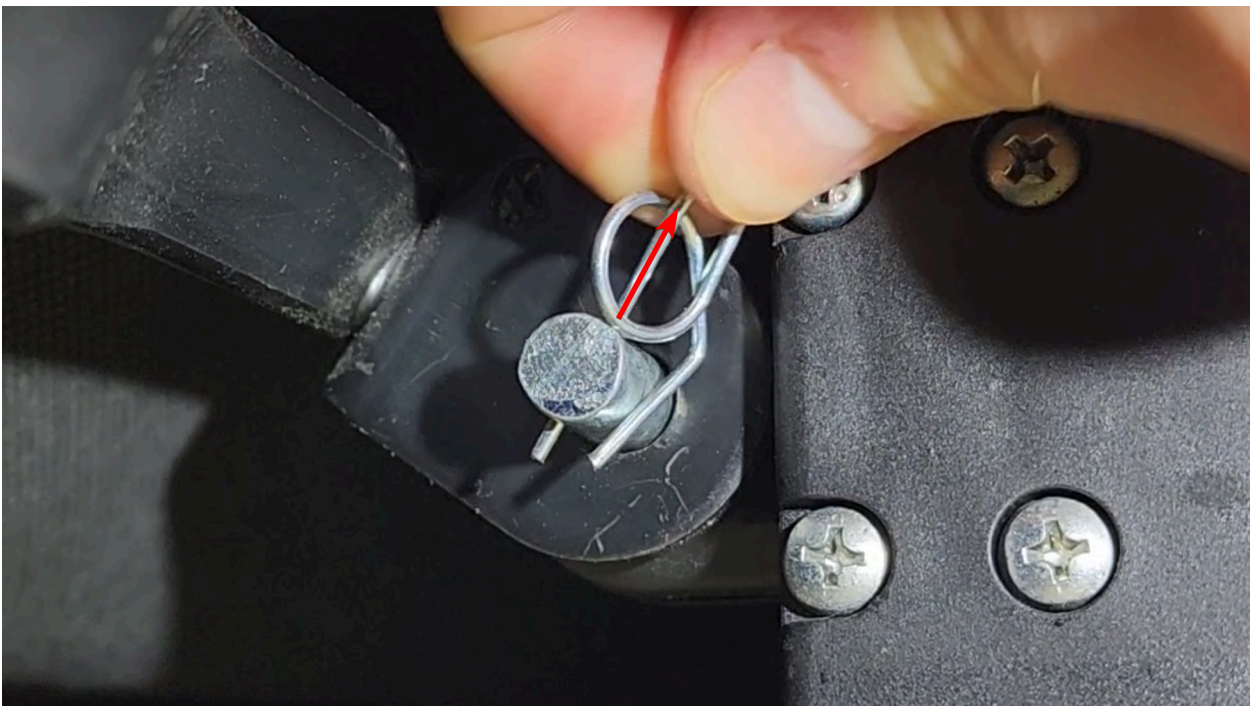
1. Before removing anything, make sure to press the button to move the recliner to the reclined position. Regardless of the chair not operating, this will help to remove the block later. Unplug the couch from the wall after this.
2. Ensure the 2 power cables are unplugged from the motor. There are small clips that hinge onto them to prevent them from coming loose. Undo the clips and unplug the two cables.
3. Undo the ring pin that is holding the main pin in place. This is best done by rotating it like this to slide the ring off the top of the main pin.

4. Pull the retaining ring pin out of the chair.
5. Assuming the block is broken, the front one will not be attached to the motor assembly. The same steps apply to remove the retaining pin and main pin.
6. Remove assembly from the chair.

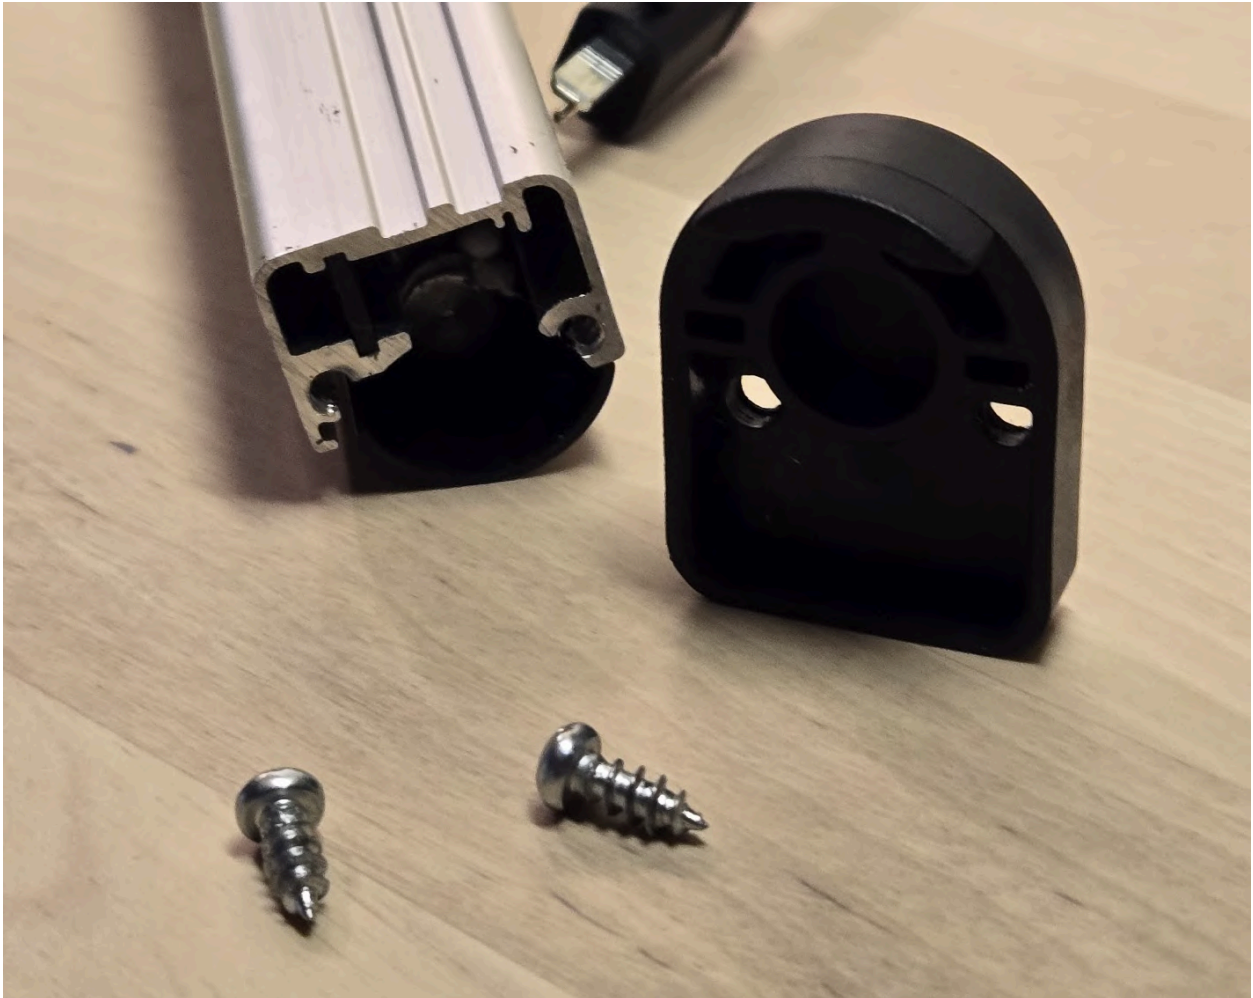
1. Remove the 2 small screws from the cap on the end of the assembly.

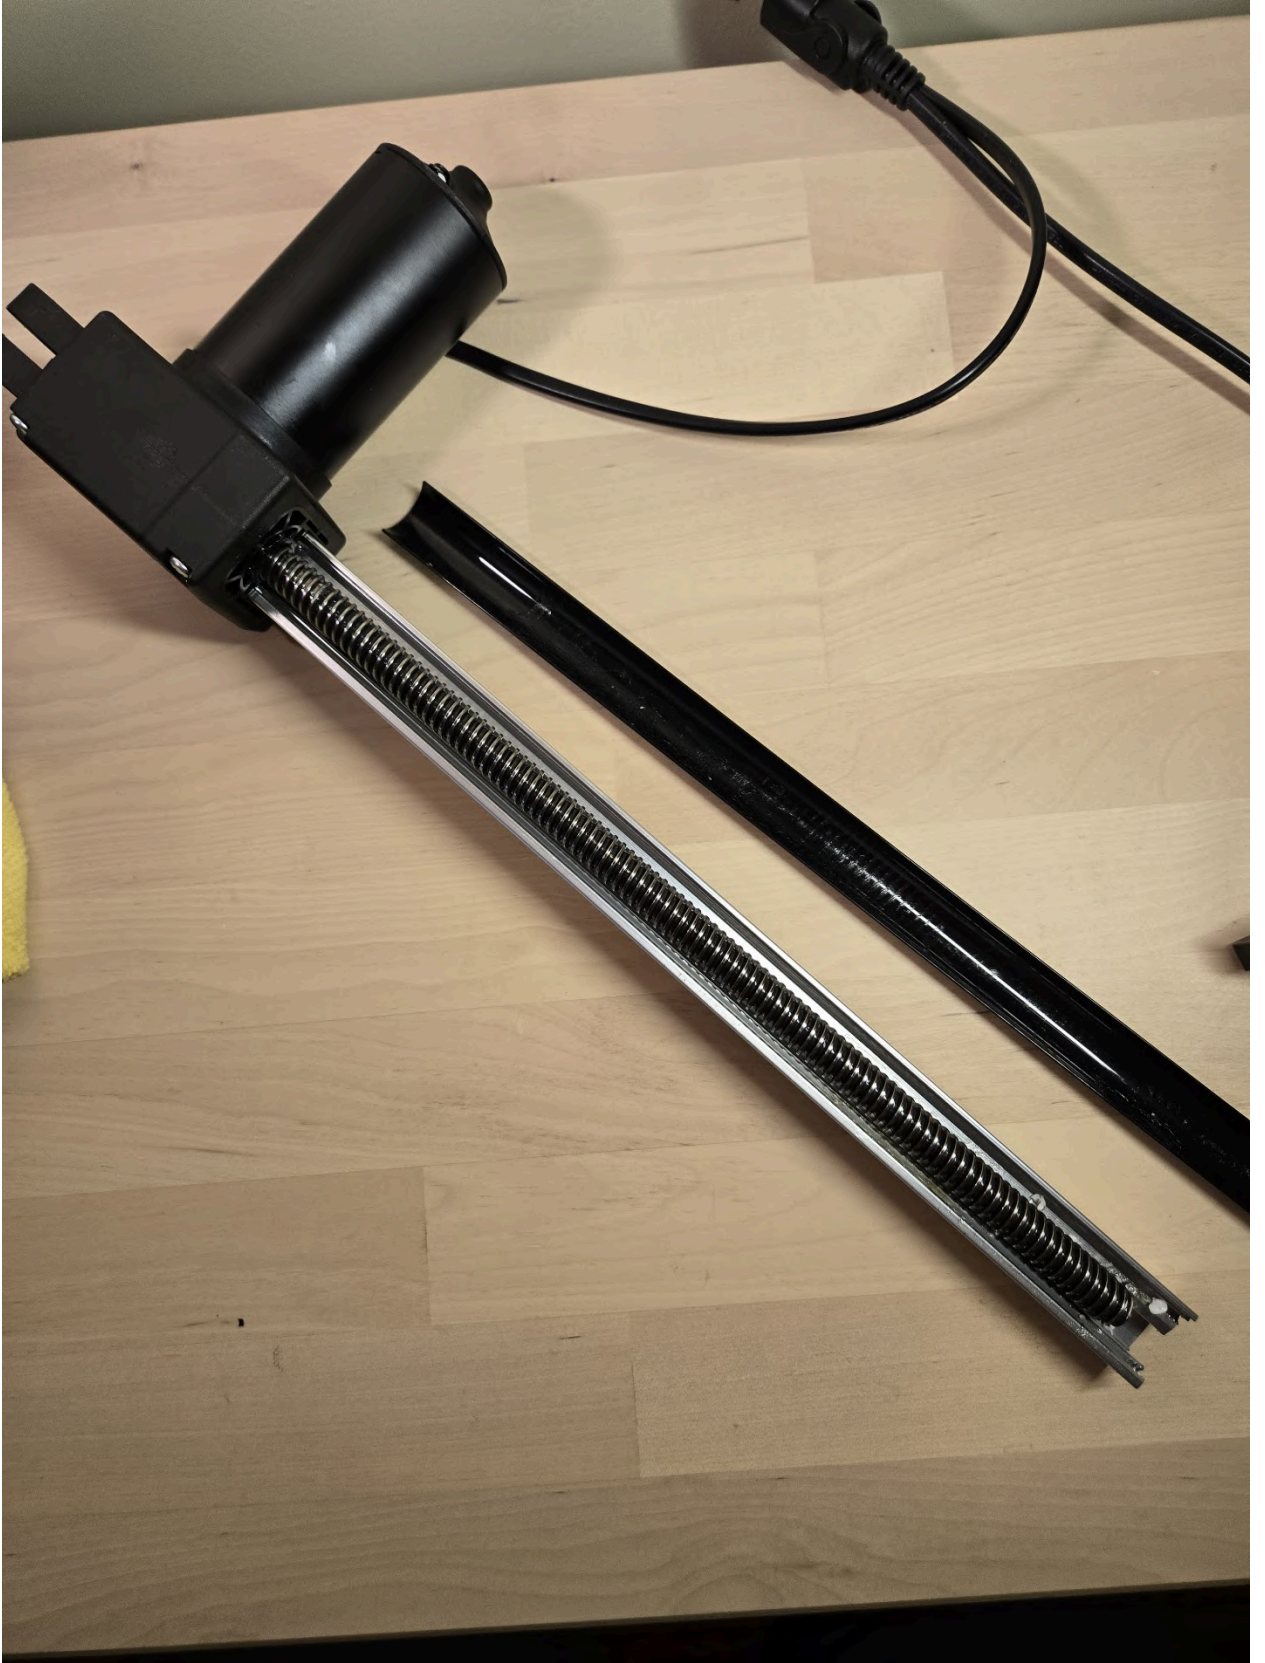
2. Remove the black plastic cover opposite of the aluminum rail.

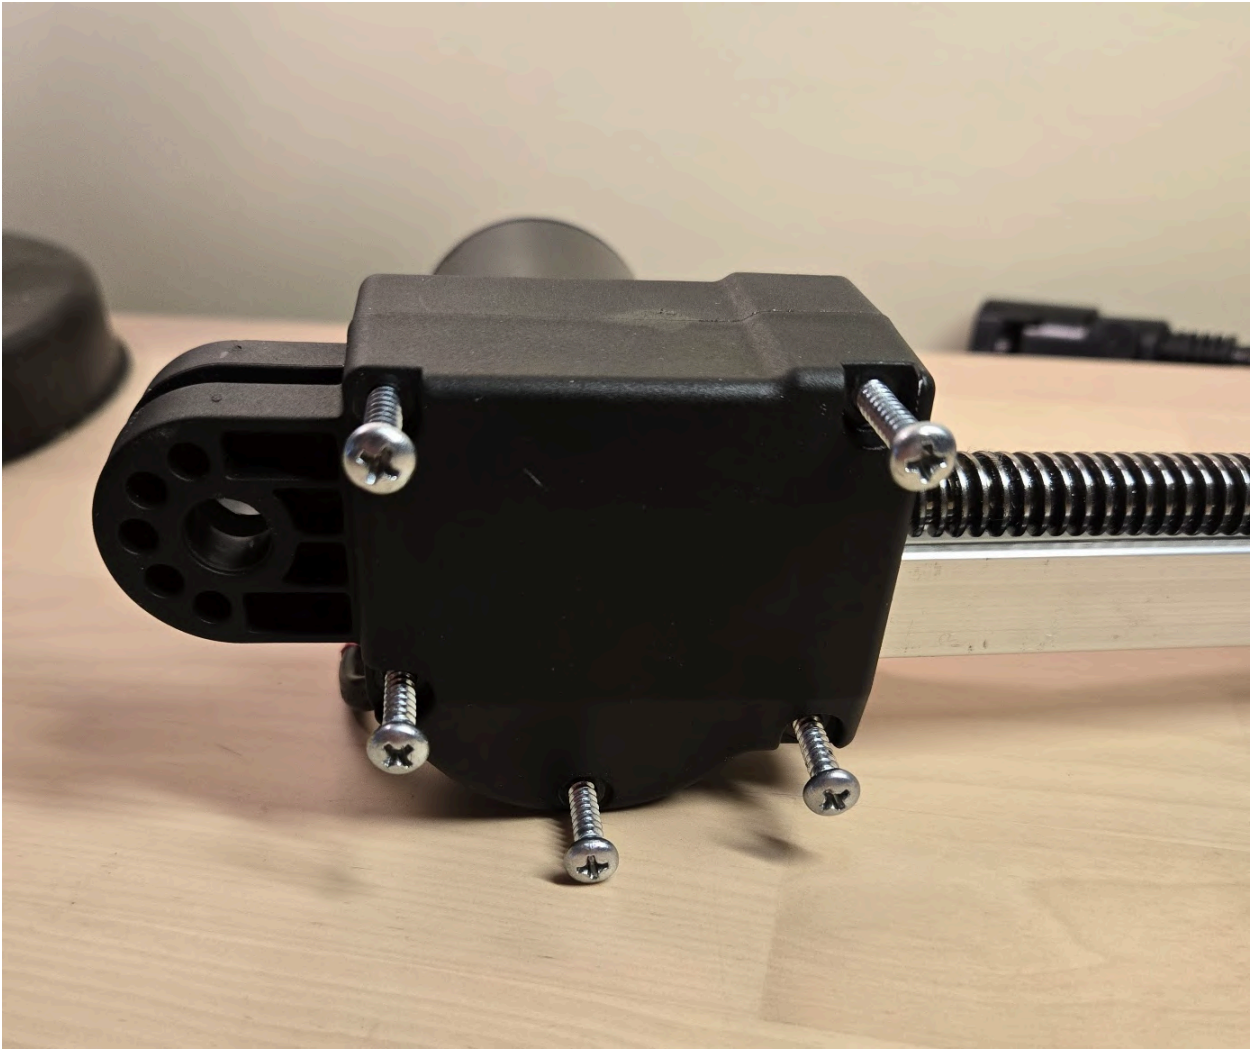
3. Remove 5 screws. These screws are quite long, I would recommend a cordless drill if it is available.

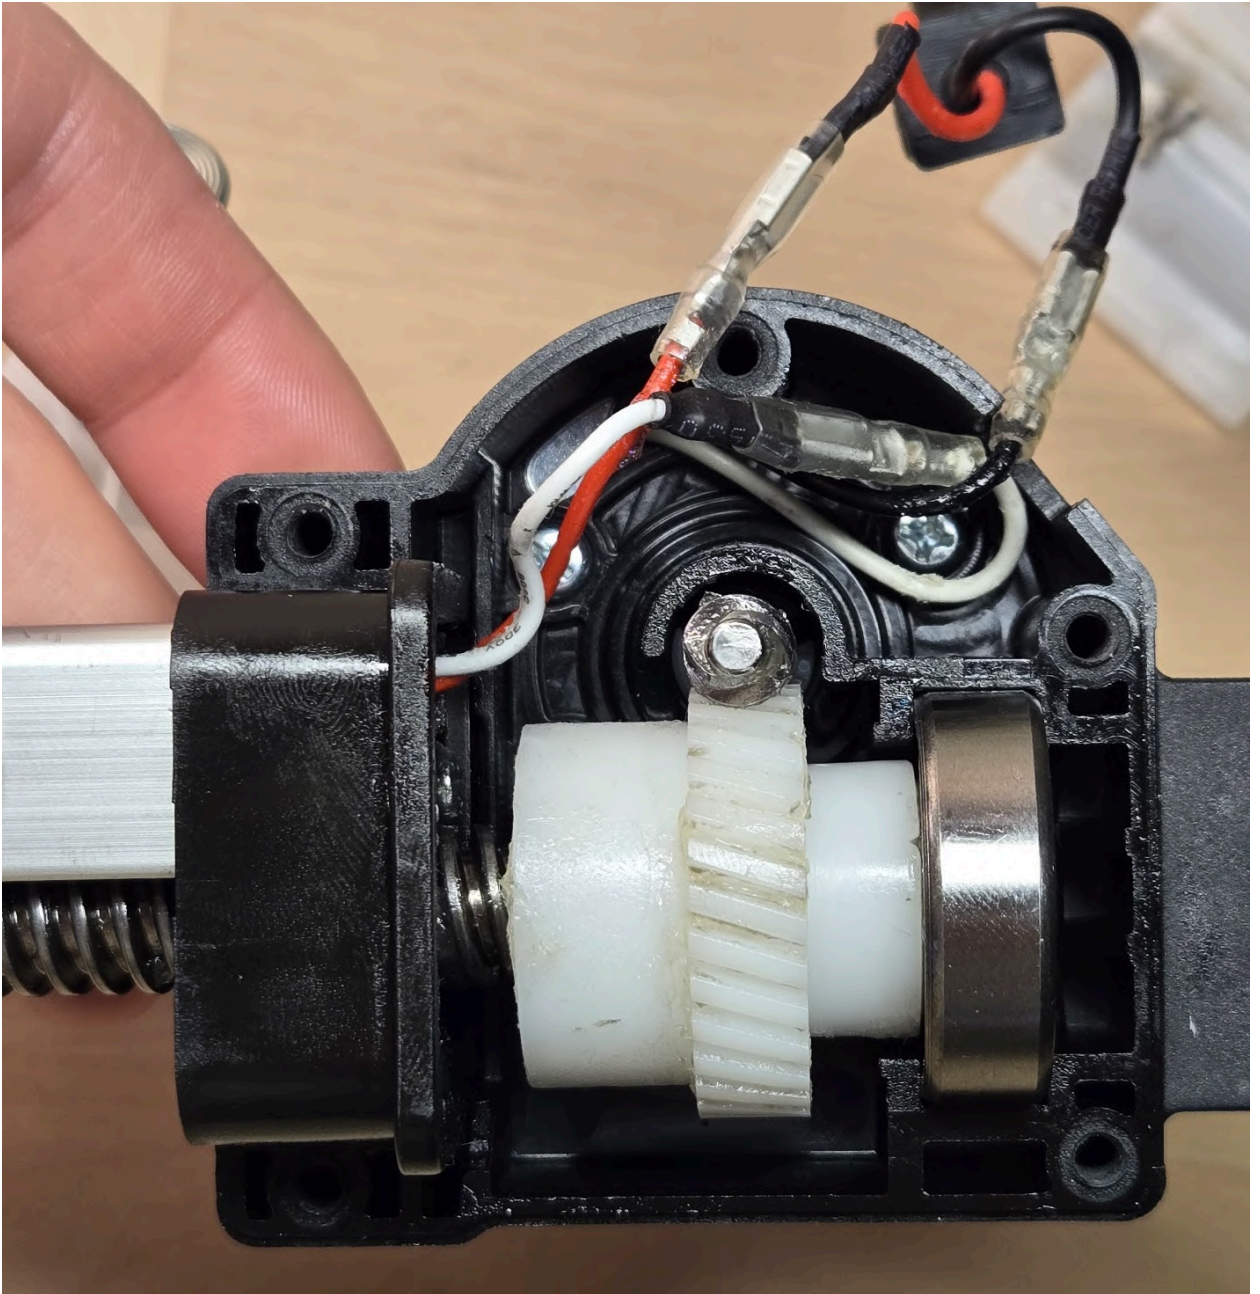
4. Remove gearbox cover. There are no clips holding it in place, only the fasteners that were just removed. Here is what that looks like:

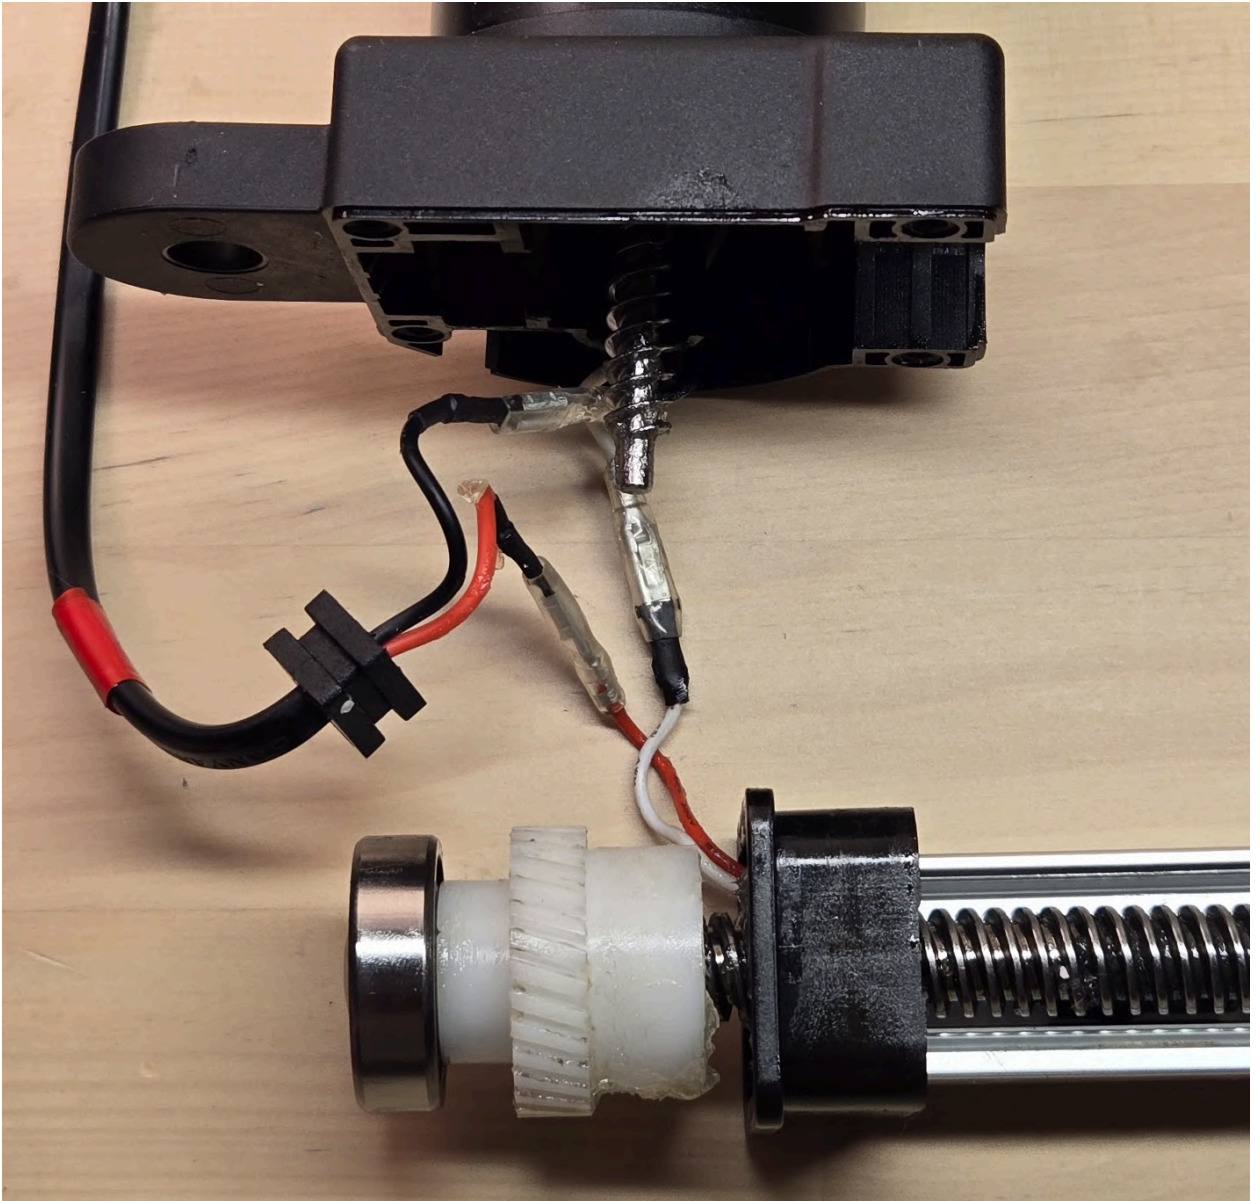
6. Rotate the plastic gear off of the worm gear. The wires do not need to be disconnected. Pulling the bottom of the plastic gear will rotate it off of the worm gear.

7. Twist the plastic gear counter-clockwise (the bearing pictured above is the top for reference) and either 2 things will happen
  - a. The broken plastic block will slide to the end of the aluminum rail and you can take it off.
  - b. The lead screw comes out and the plastic block doesn't move. If this happens keep going in the same direction, then push the lead screw down back into the aluminum rail. This will push the plastic block off the end. Repeat as many times as necessary to remove the block.

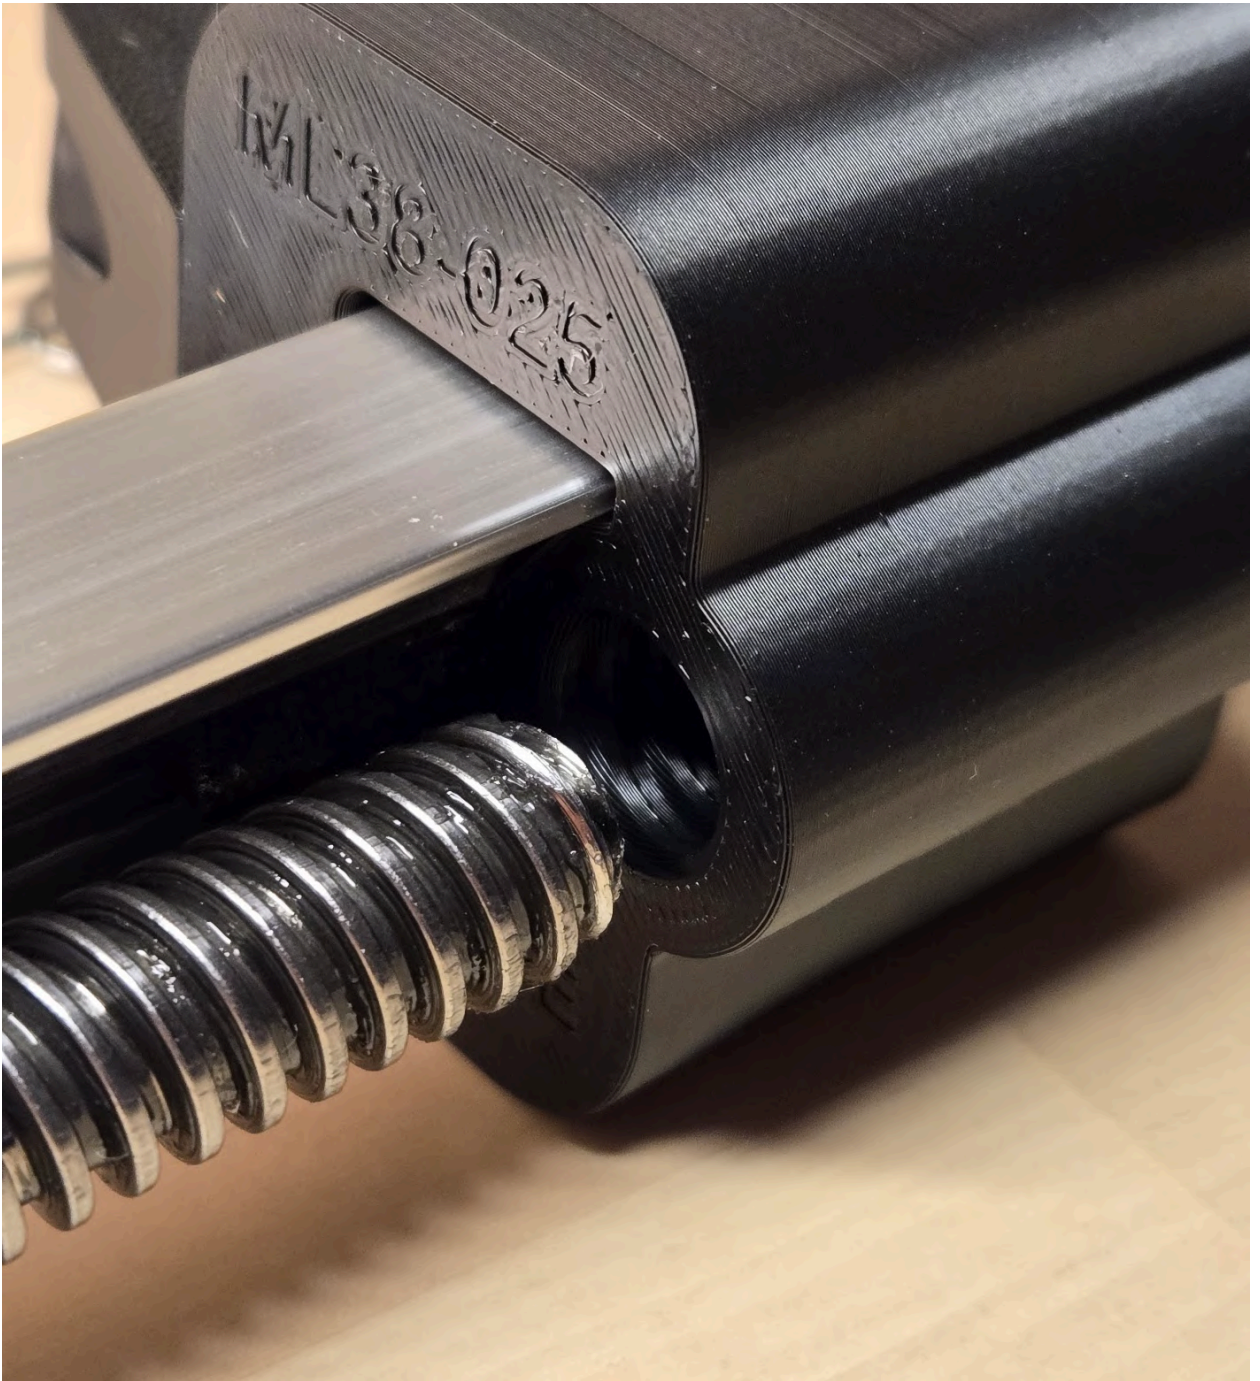
9. Place the new block on the aluminum rail, with the "MOTOR SIDE" text facing the motor. All text is on the same side of the block, so as long as the text side is facing the motor you're good.

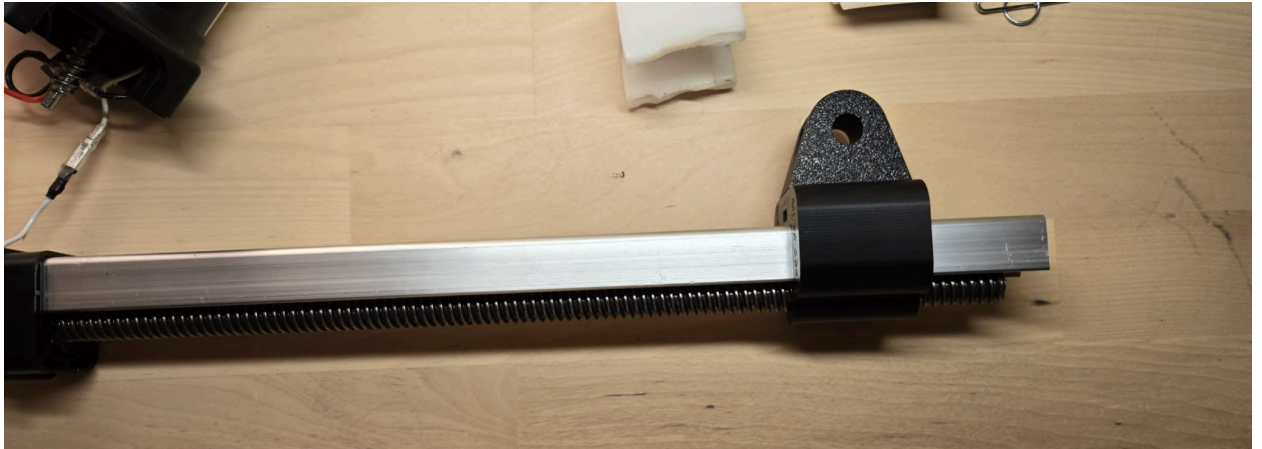
10. Slide the block down the aluminum rail, until it hits the lead screw.

11. Turn the lead screw with the plastic gear clockwise so it goes into the block.
  - a. Turning the lead screw this direction will force the plastic gear into the aluminum rail screws pictured in the photo above. To more easily screw on the block, pull the lead screw out a little to avoid this.
12. Ensure the block is fully on the aluminum rail with at least 2-3 inches of extra rail past the block. (Position pictured above)

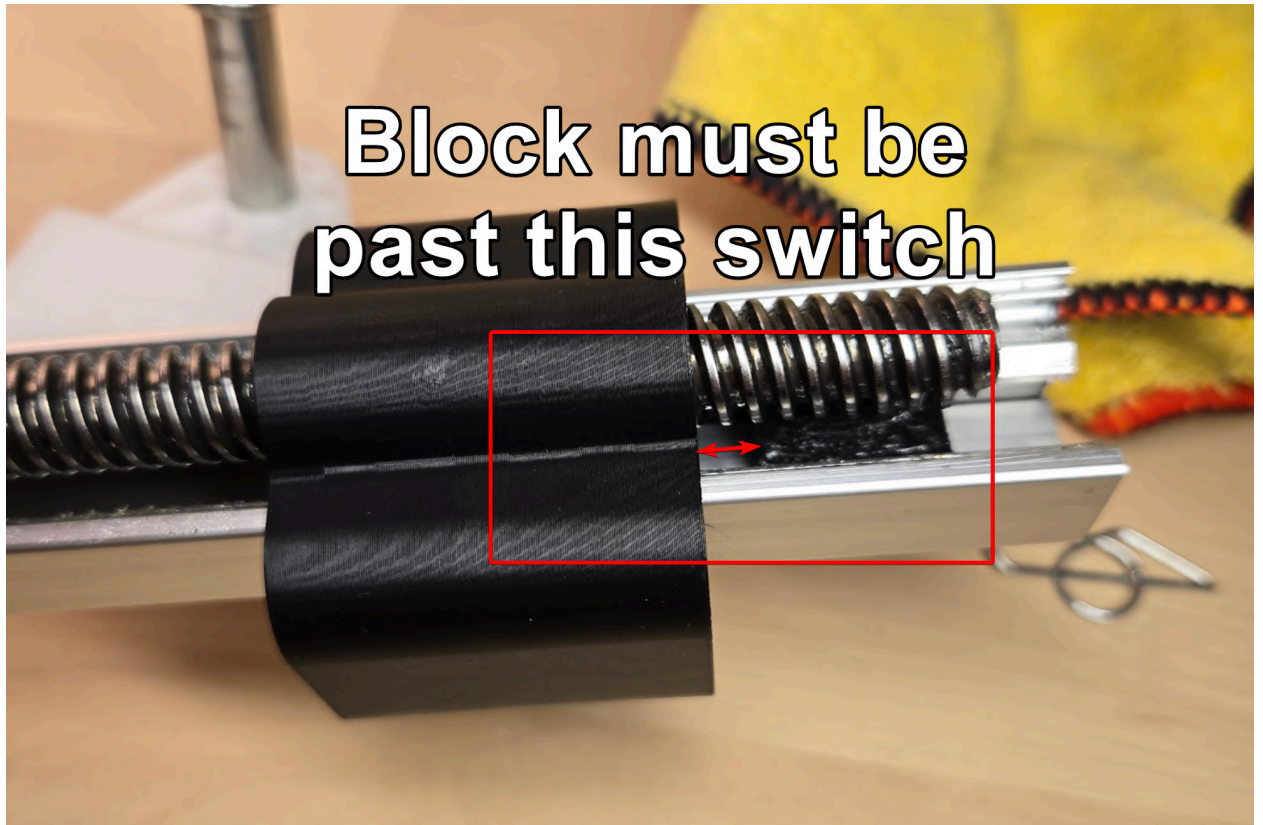
13. It is important that the block goes past the electronic limit switch pictured below. If it is not, the motor will be unable to move the block in the intended direction.

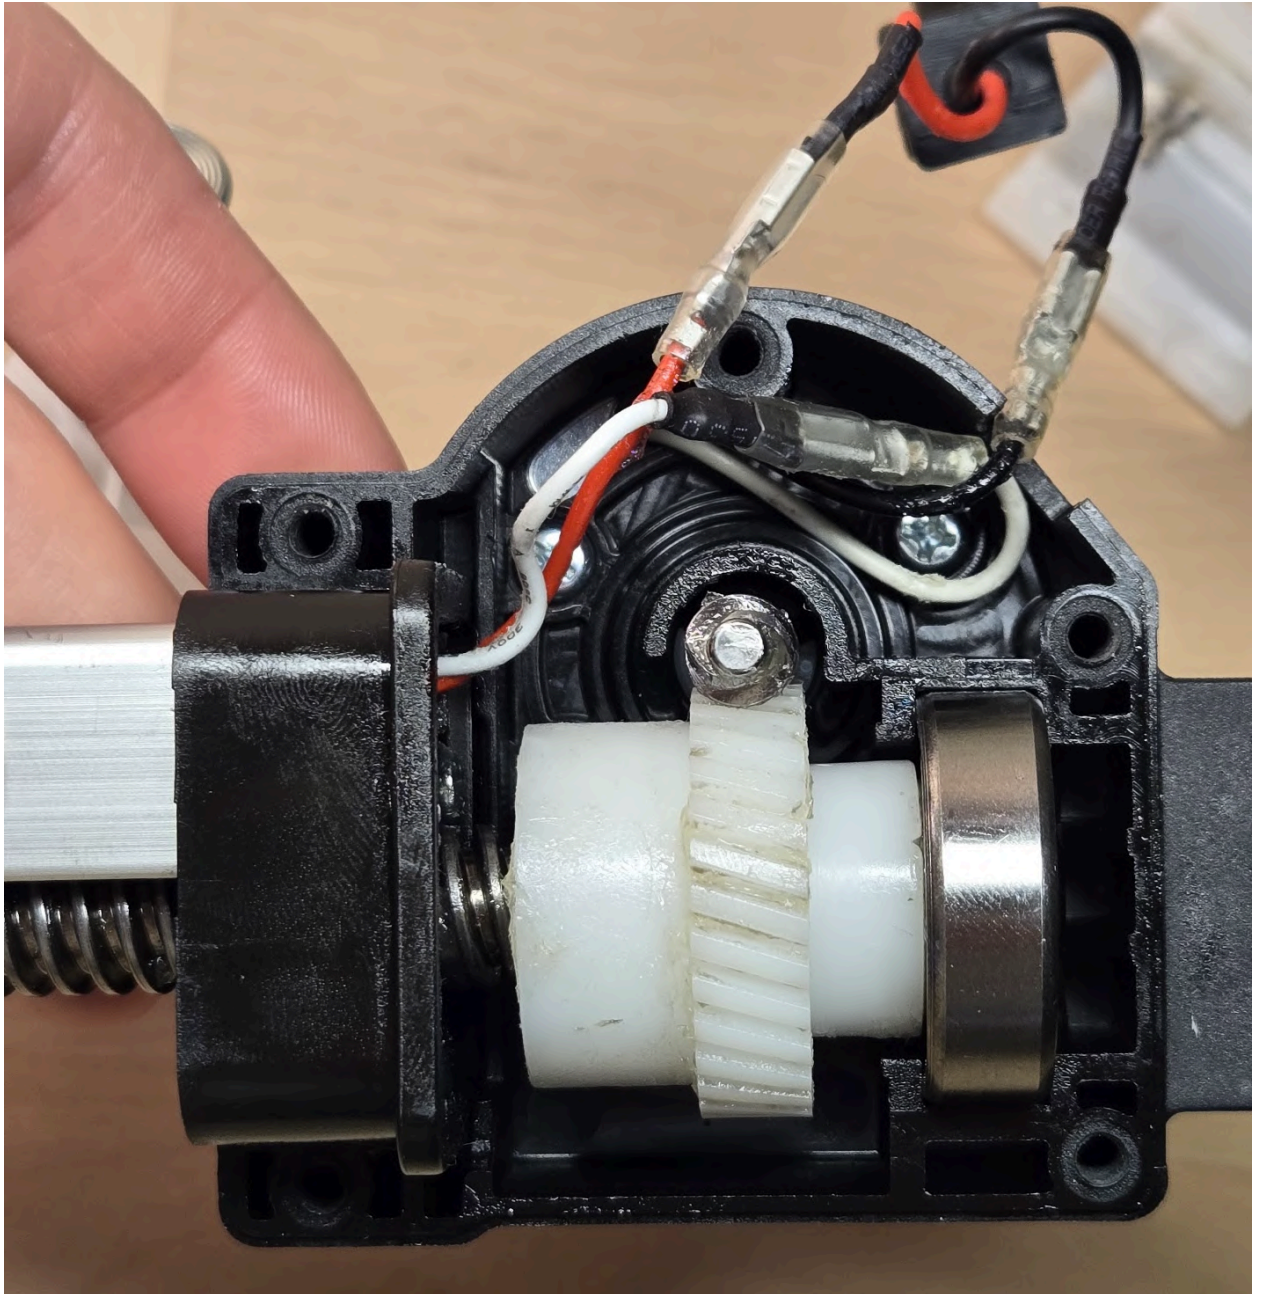
14. Press the plastic gear, bearing, and rail back in the motor housing. This part can be finicky due to the rotation of the gear causing the lead screw to shorten in length.

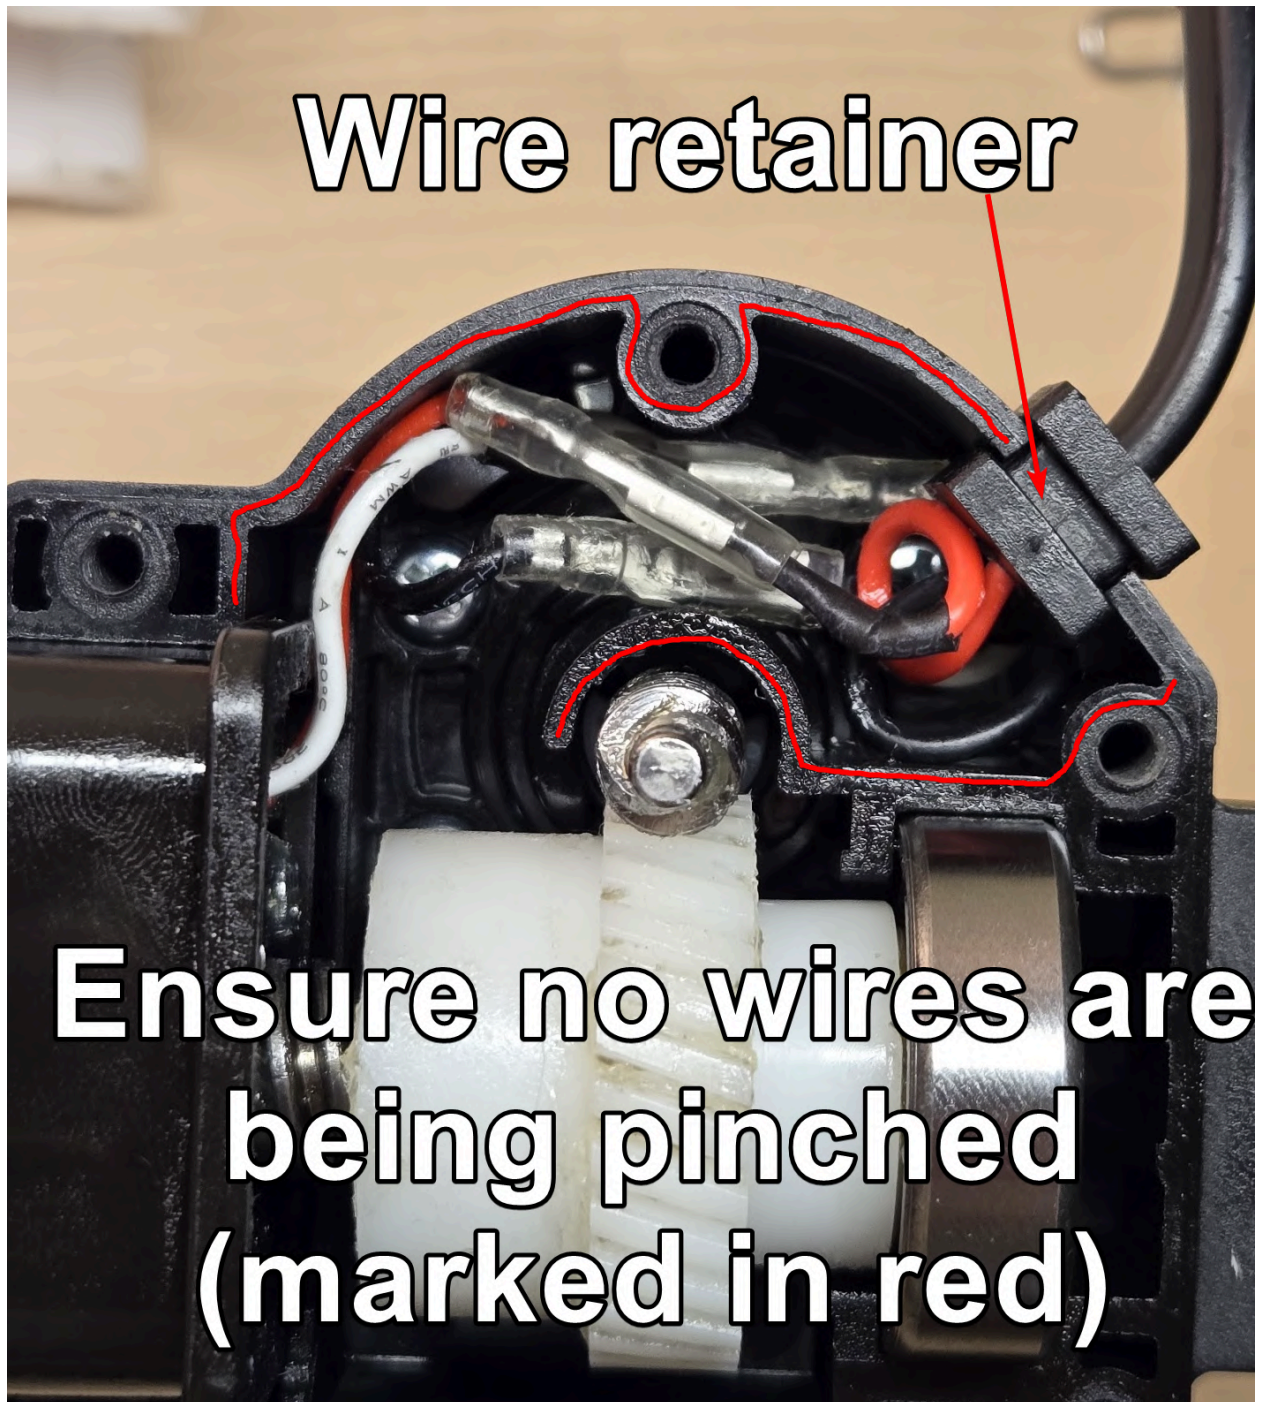
15. Get the wiring to fit back into the empty space made for it, and ensure the cable strain relief(wire retainer) is lined up with the housing case.

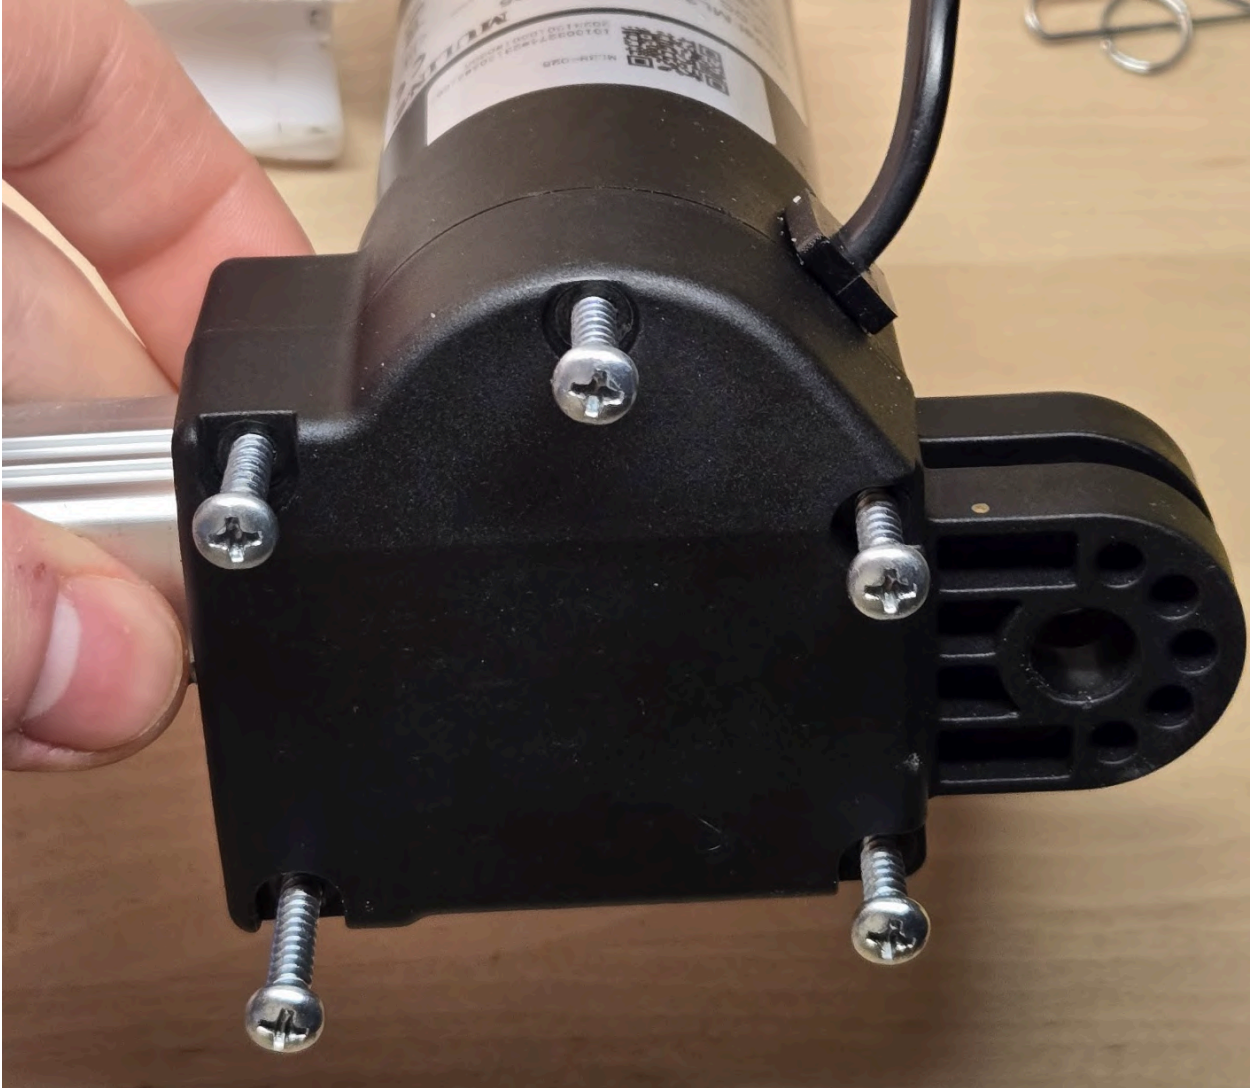
16. Do not pinch any of the cables in the gearbox housing. Doing this can potentially damage the wires.

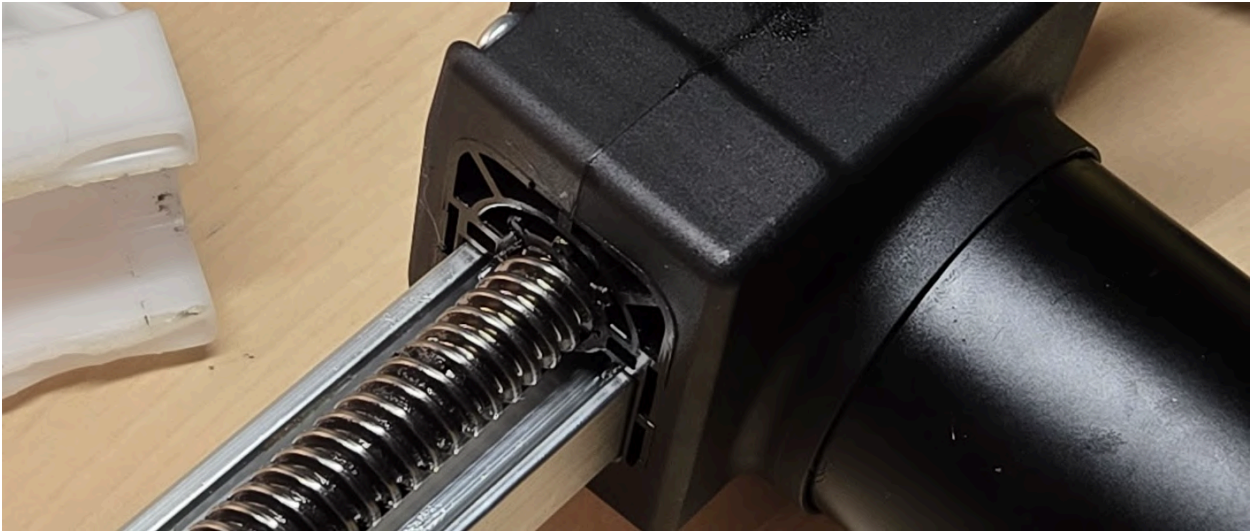
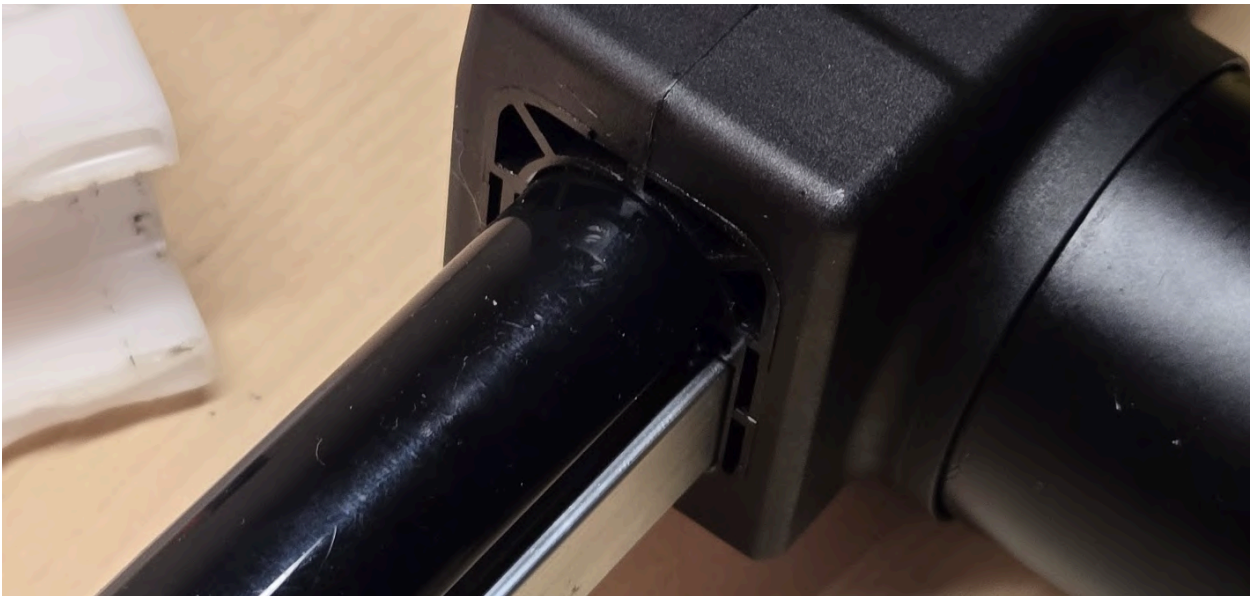
18. Replace the plastic half of the rail that covers the main screw.

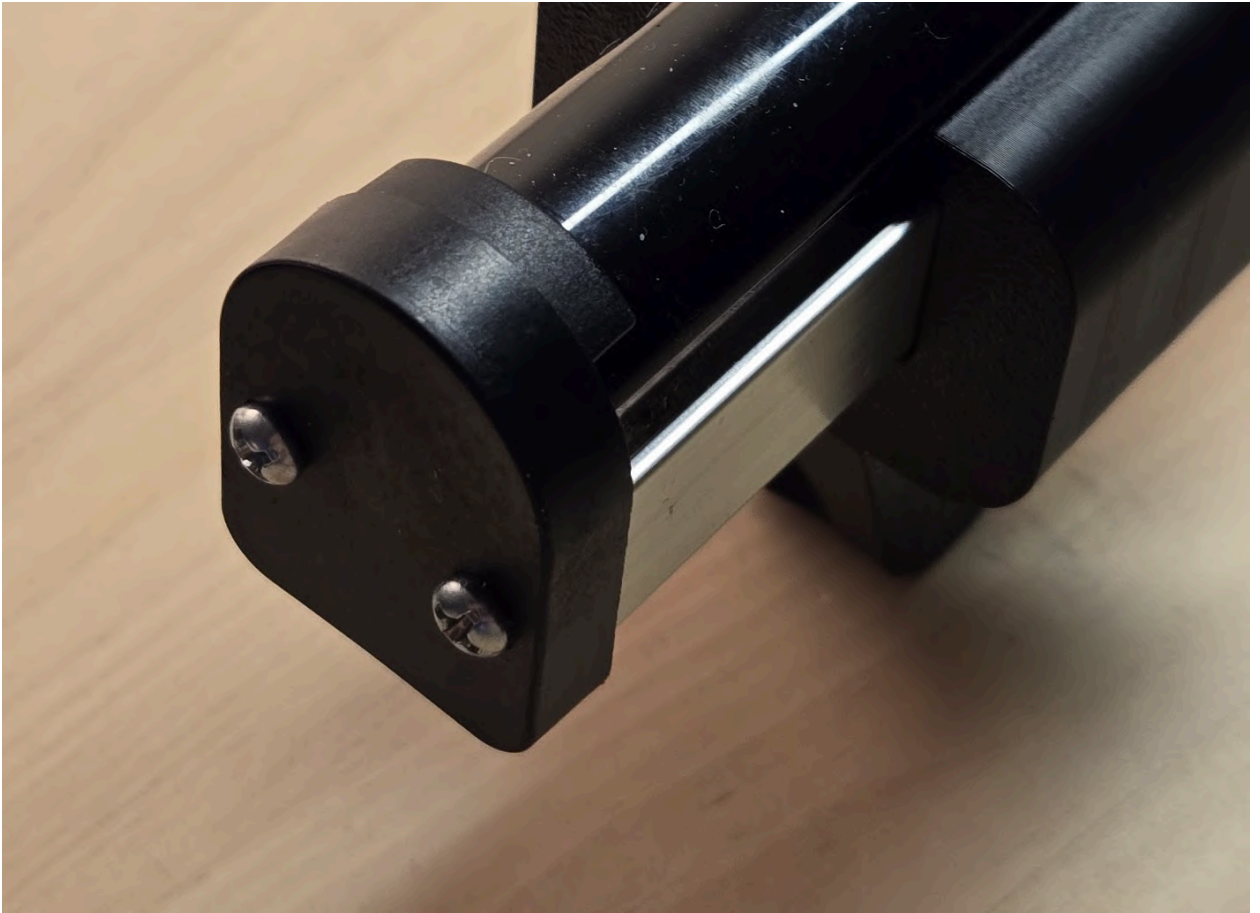
19. Reattach the cap at the end of the aluminum rail.

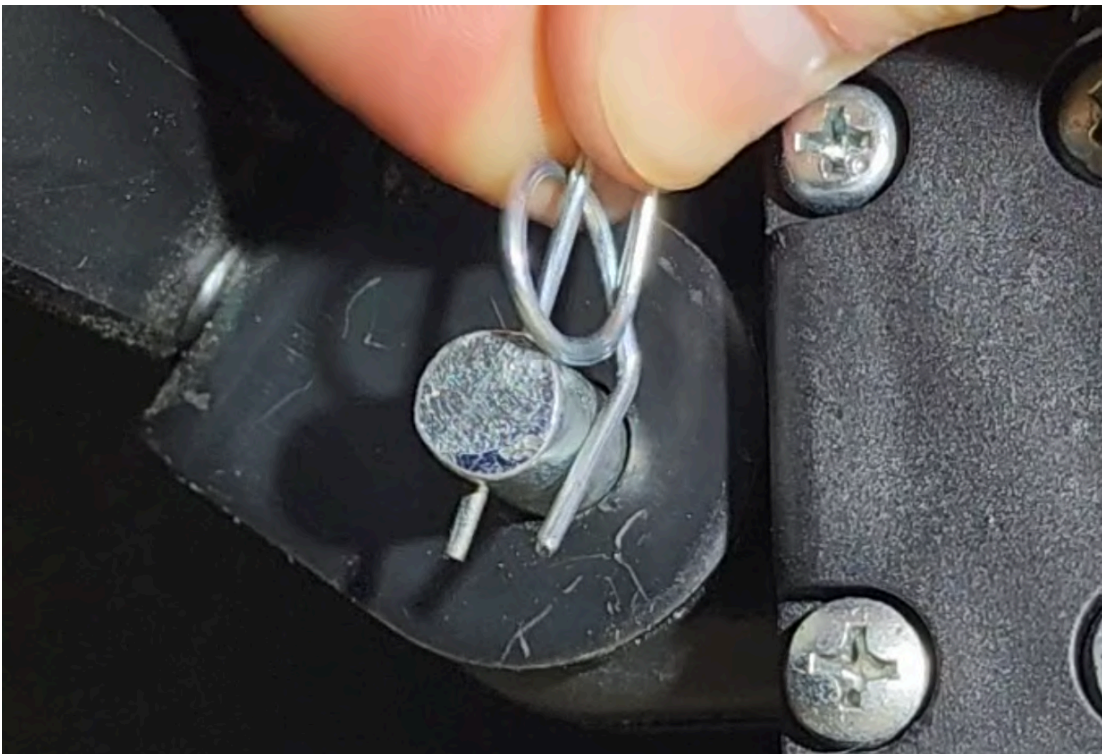
5. Push the retaining ring pin in, flat side through the hole.
