# Mulin ML38-025 Linear Actuator Block Replacement

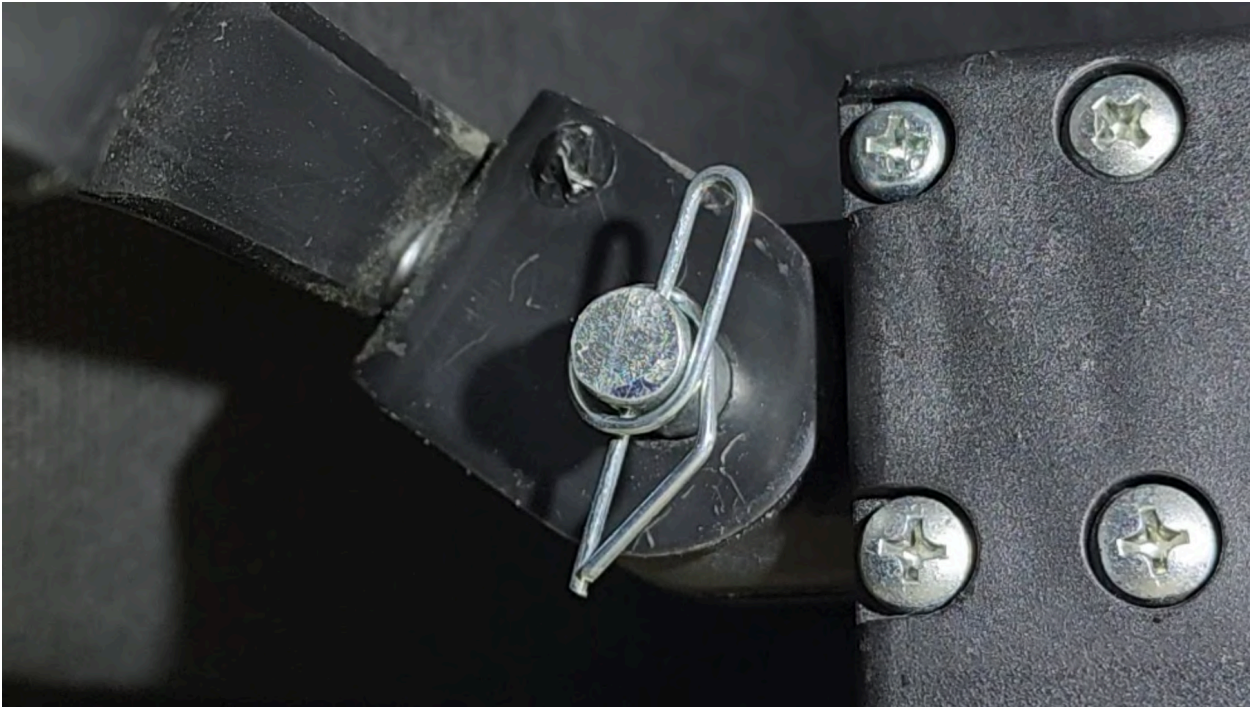
6. Twist the retaining ring pin so that the ring snaps into the locked position on the main pin. It should look like this when complete.

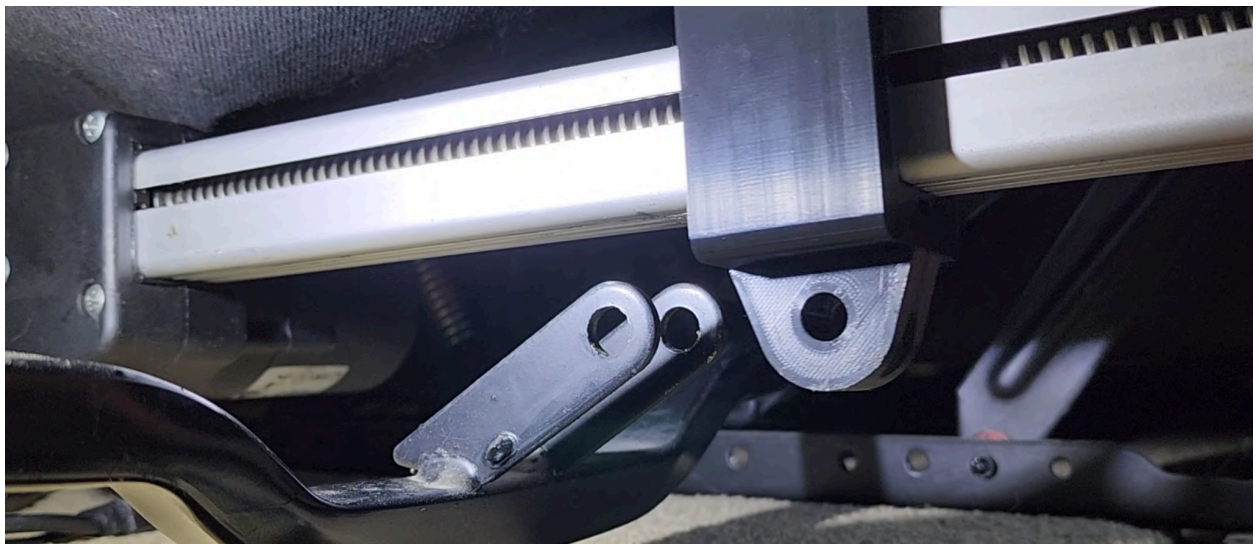
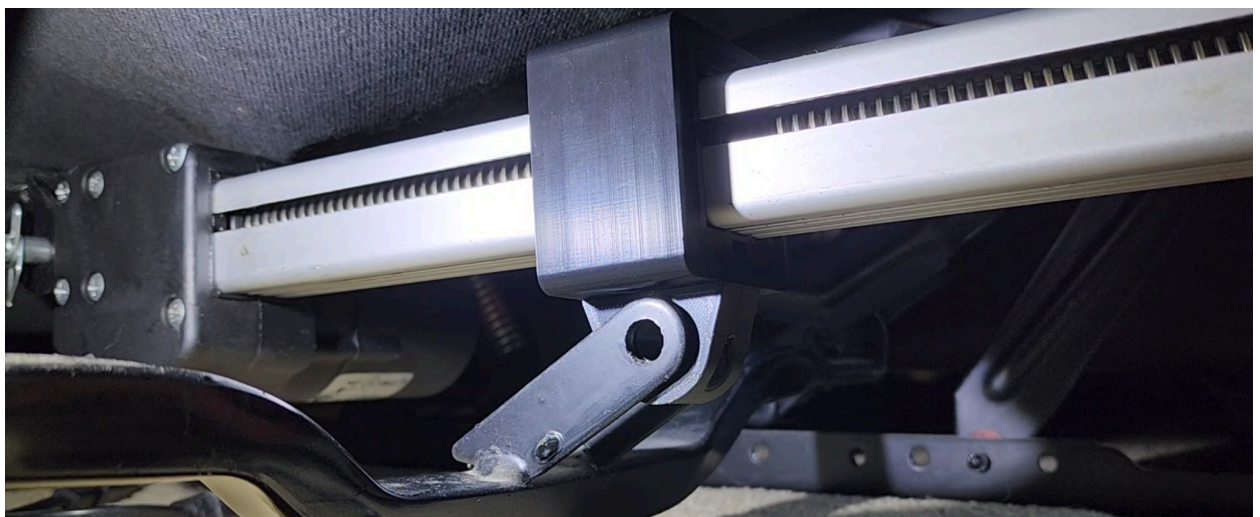
7. Plug the couch into the wall.
  - a. Due to the moving position of the recliner (assuming you are laying under it), the block will not line up with the couch recliner holes at all.
  - b. Use the recliner buttons to move the block to the correct position for inserting the main pin.

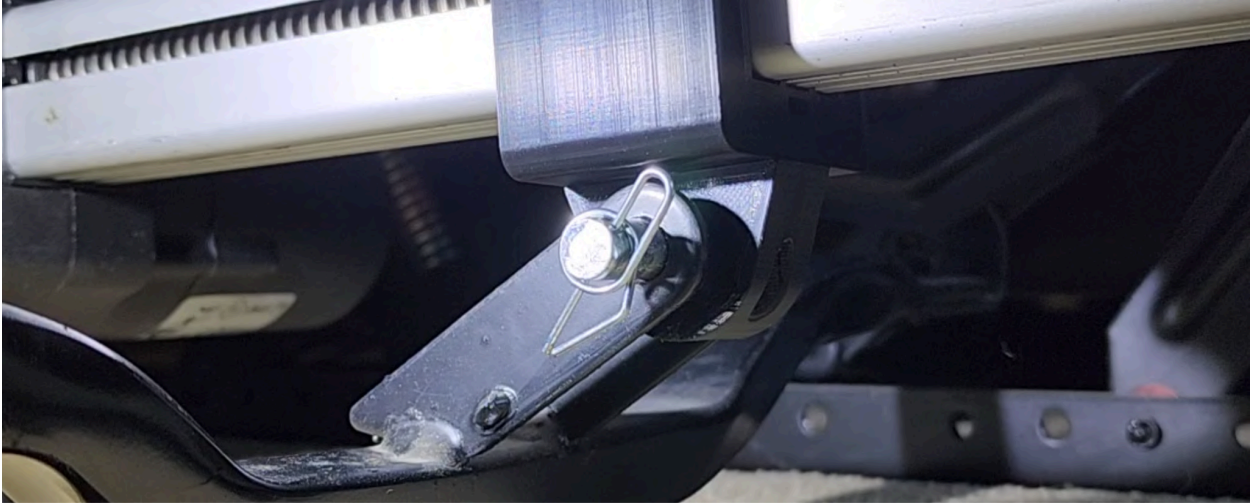
8. Repeat the same insertion steps as the back main pin.
