# Mulin Electric ML8-145 Block Replacement

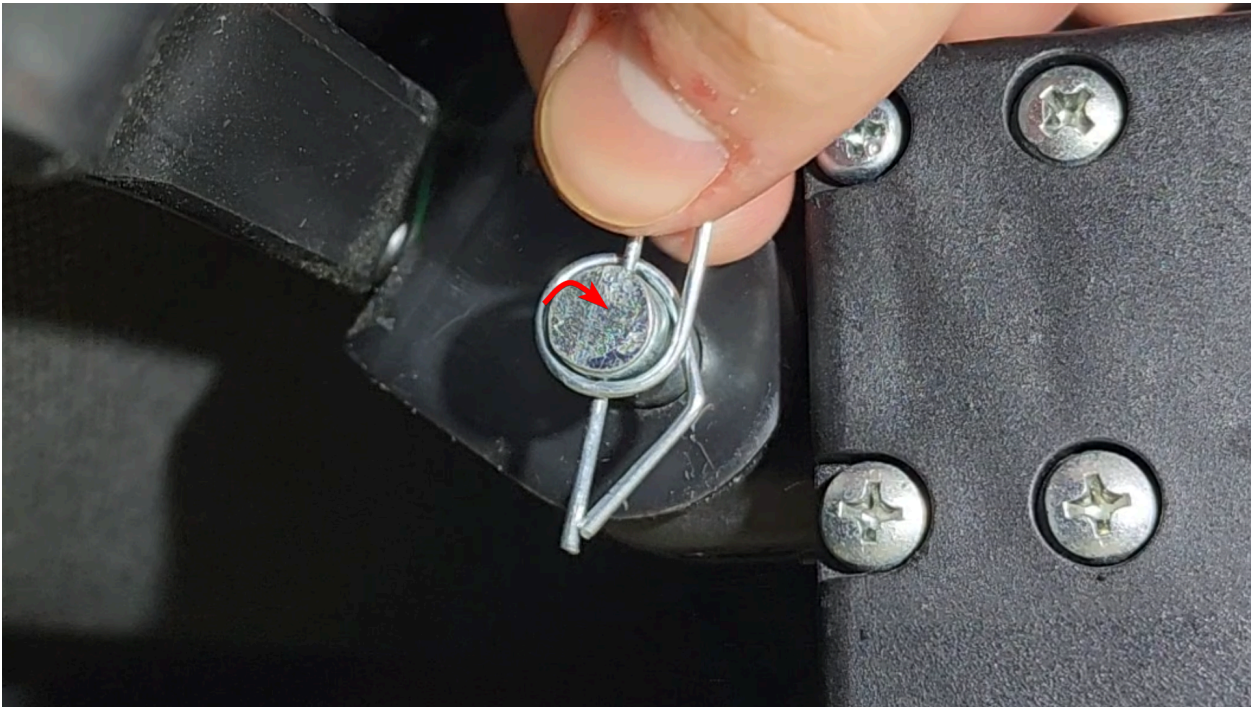
1. Before removing anything, make sure to press the button to move the recliner to the reclined position. Regardless of the chair not operating, this will help to remove the block later. Unplug the couch from the wall after this.
2. Ensure the 2 power cables are unplugged from the motor. There are small clips that hinge onto them to prevent them from coming loose. Undo the clips and unplug the two cables.
3. Undo the ring pin that is holding the main pin in place. This is best done by rotating it like this to slide the ring off the top of the main pin.

4. Pull the retaining ring pin out of the chair.
5. Assuming the block is broken, the front one will not be attached to the motor assembly. The same steps apply to remove the retaining pin and main pin.
6. Remove assembly from the chair.

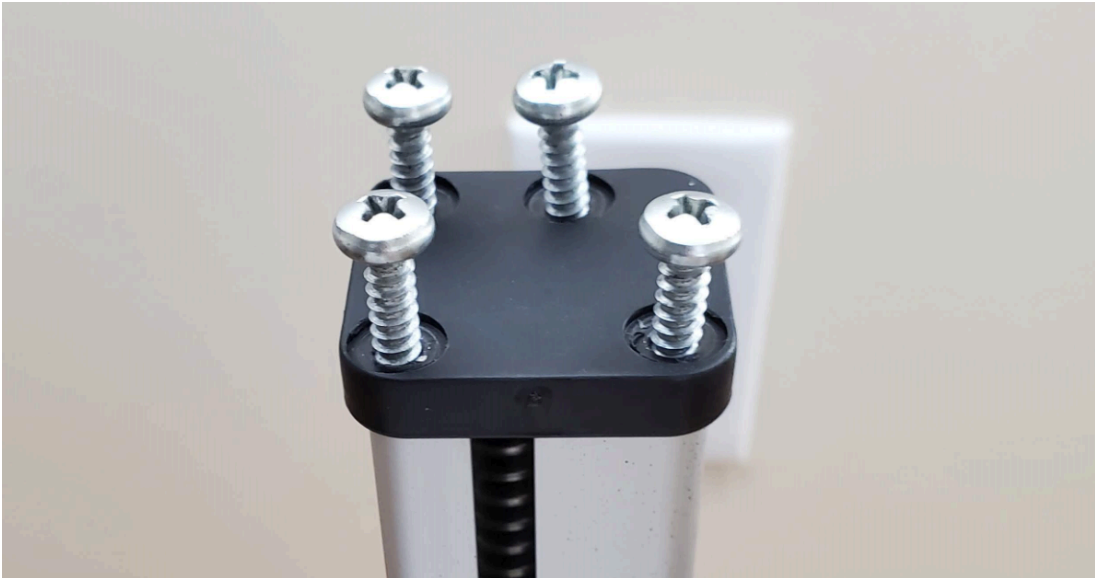
1. Remove the 4 small screws from the cap on the end of the assembly.

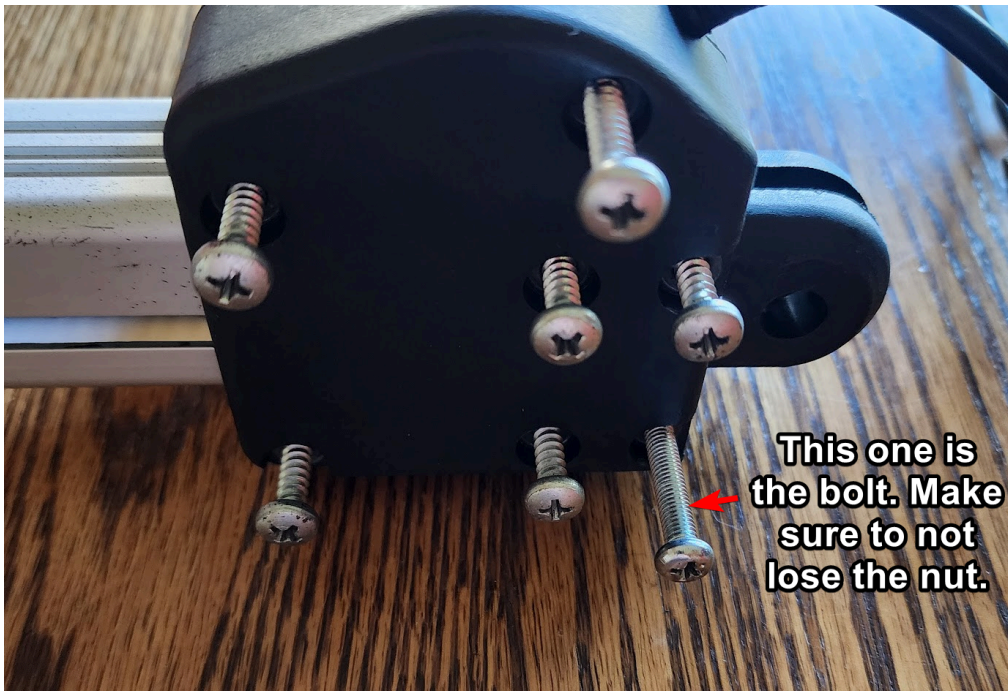
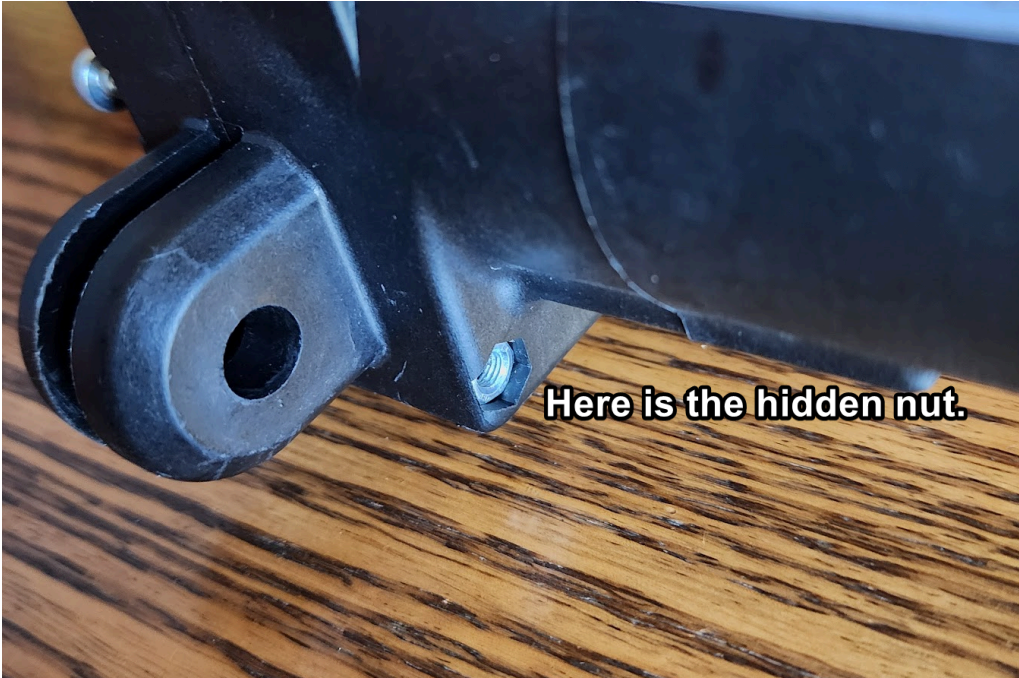
2. Remove 6 screws and 1 bolt with a nut. These screws are quite long, I would recommend a cordless drill if it is available.

**Here is the hidden nut.**

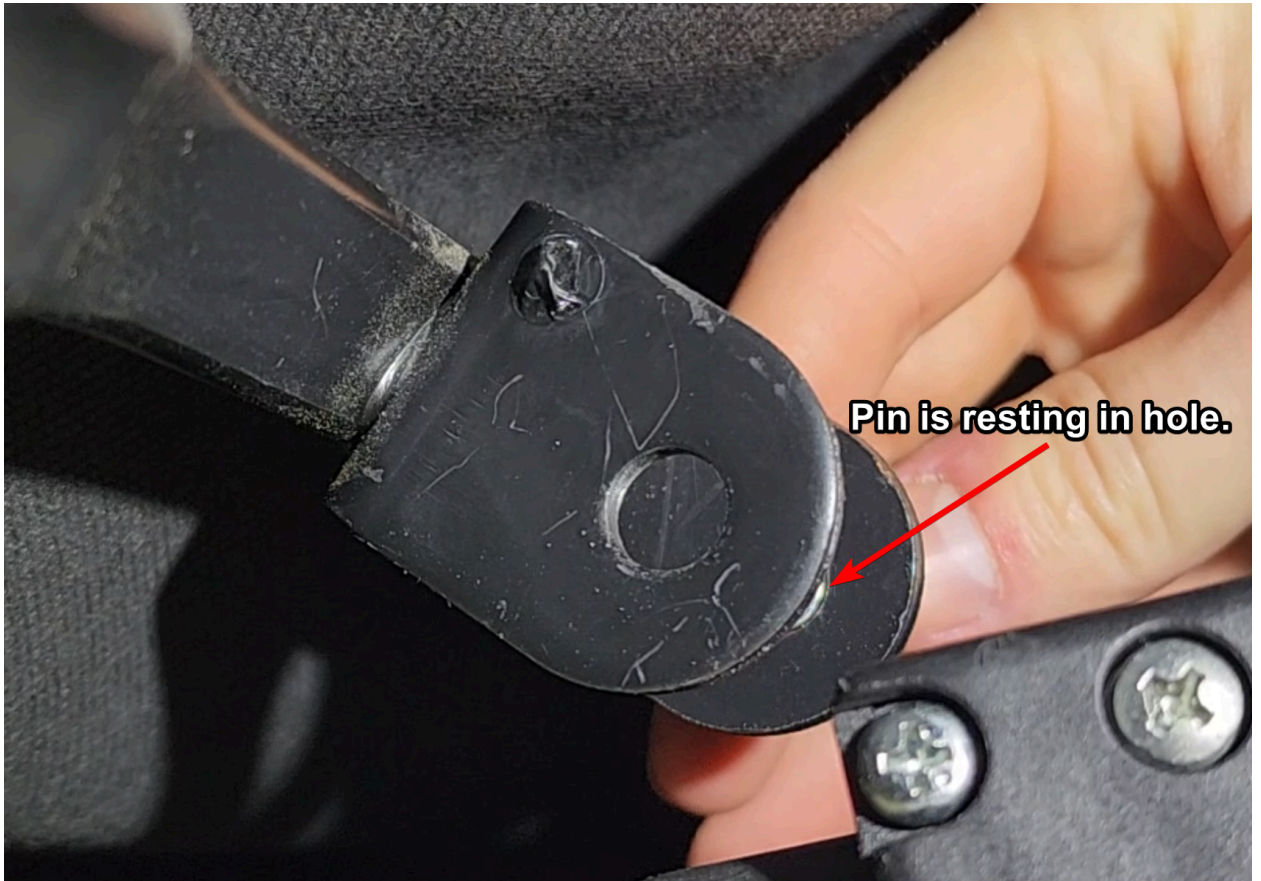
1. Before attaching either of the pins, the couch should still be unplugged from the wall.
2. Plug the two couch cables back into the motor.
3. Start with the rear pin, where the motor is. I found that resting the pin in the hole very shallowly helped with getting it through the two plates and assembly.

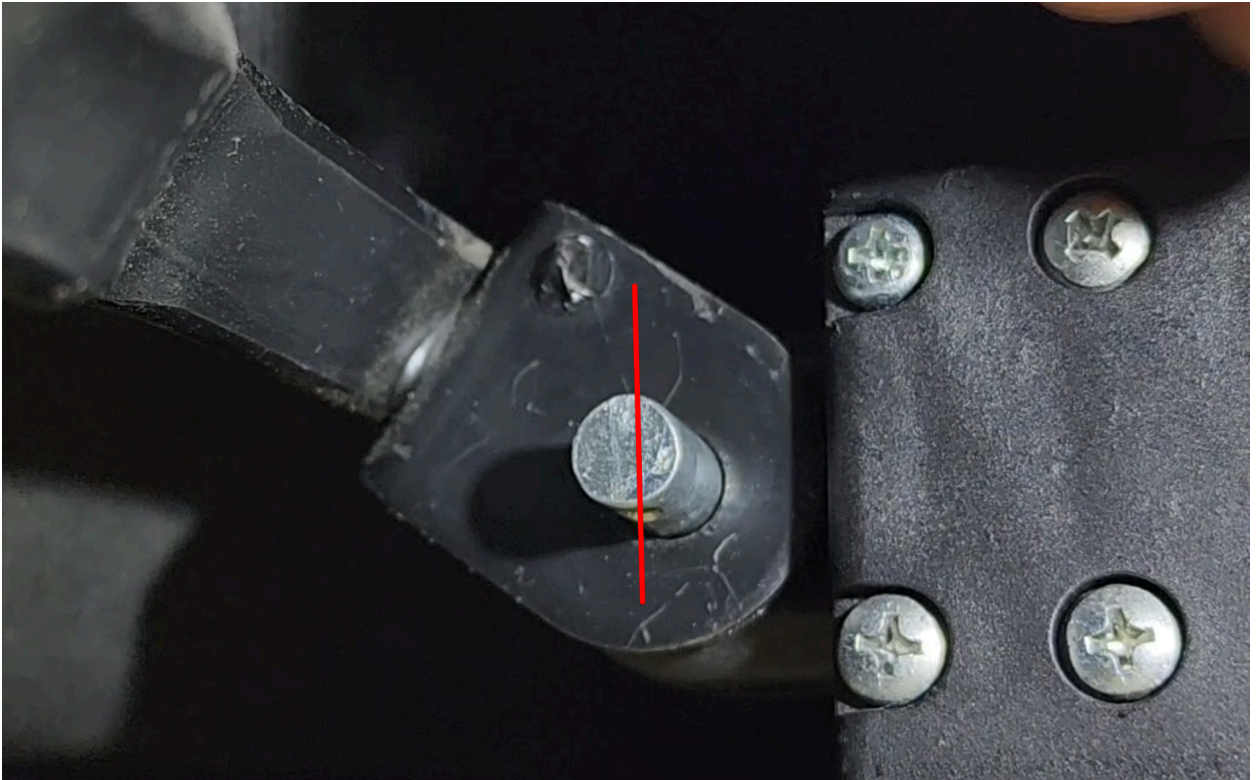
4. Make sure the hole in the main pin is roughly up/down so that the retaining ring pin can be pushed in easily.

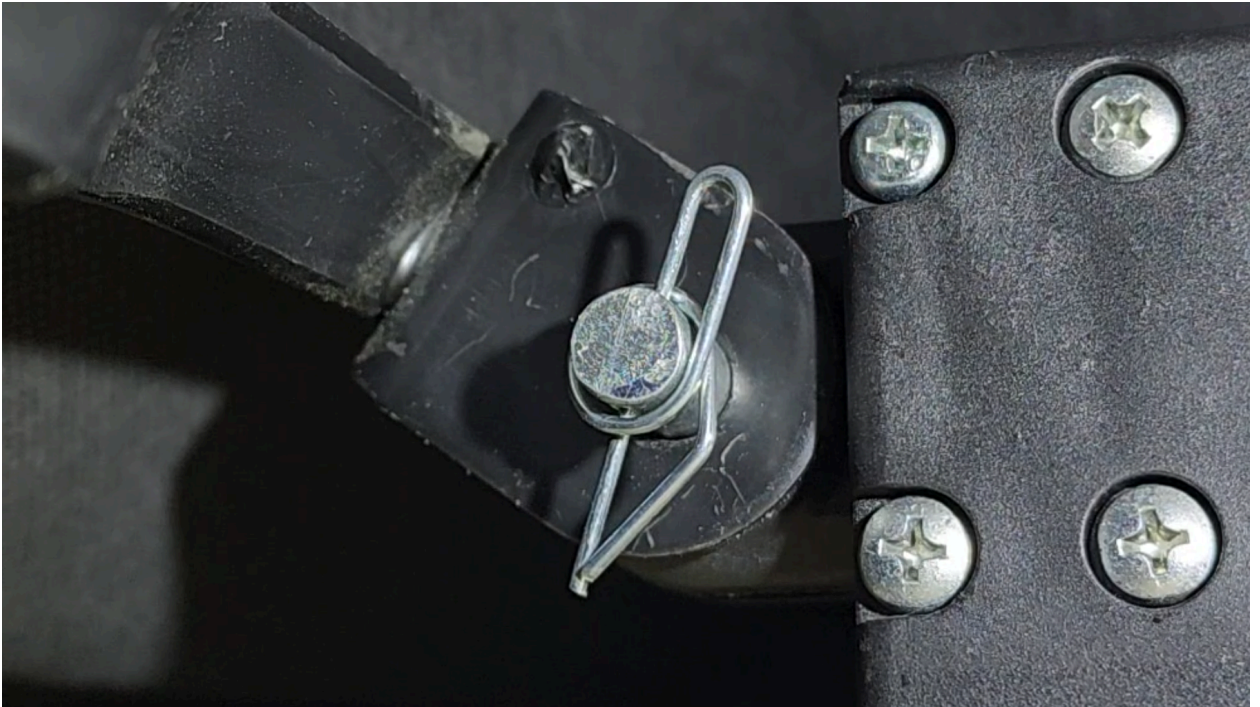
6. Twist the retaining ring pin so that the ring snaps into the locked position on the main pin. It should look like this when complete.

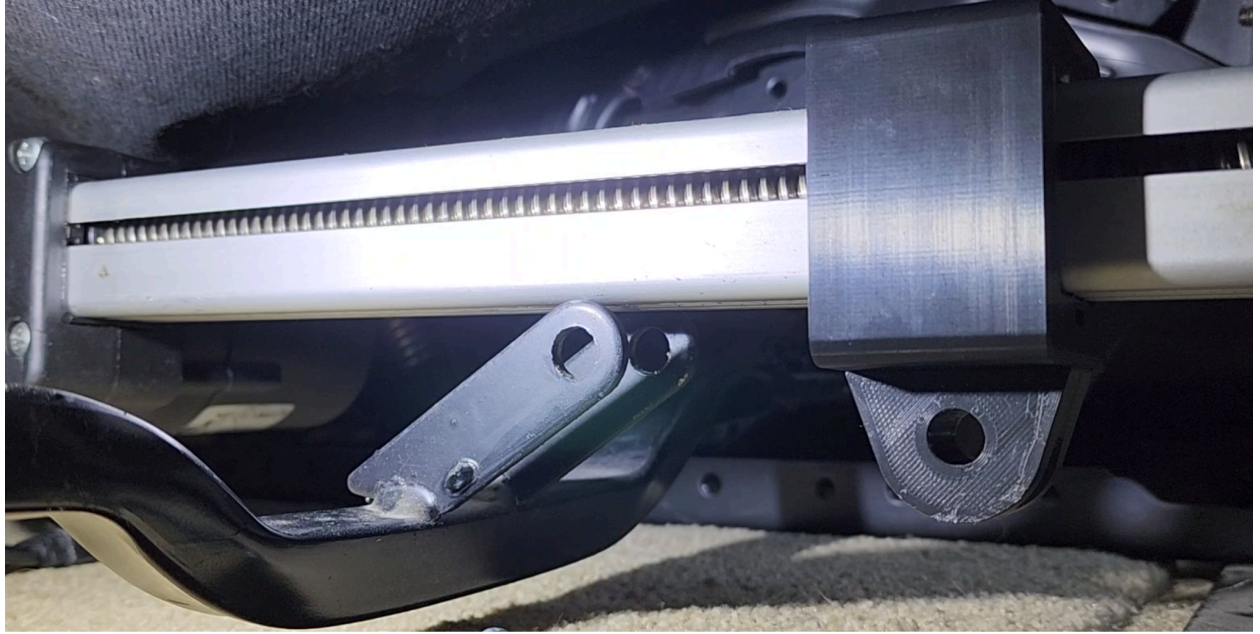
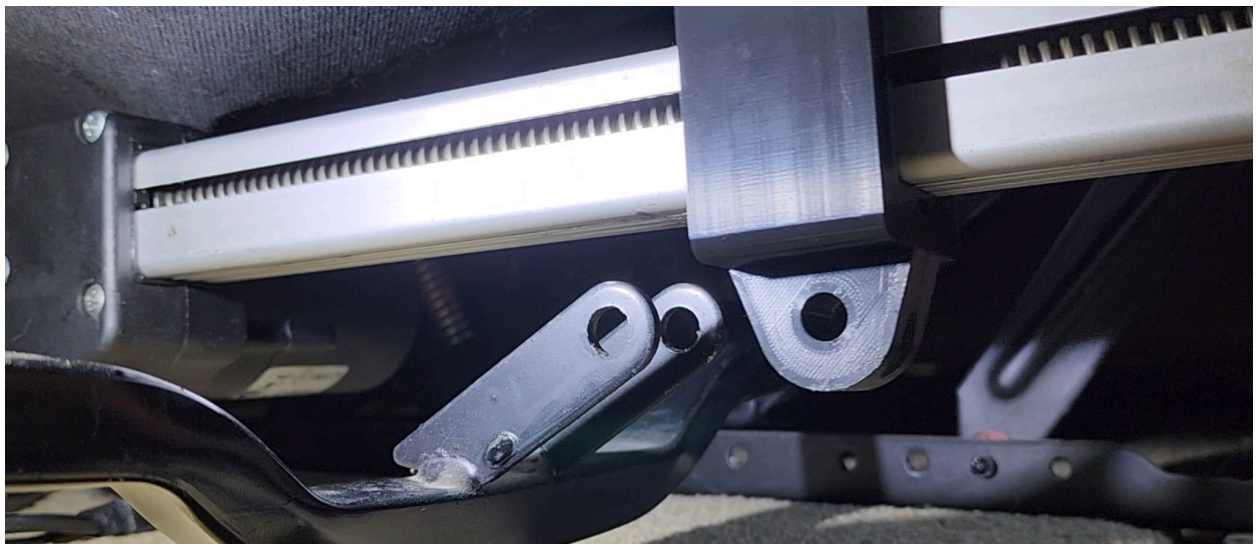
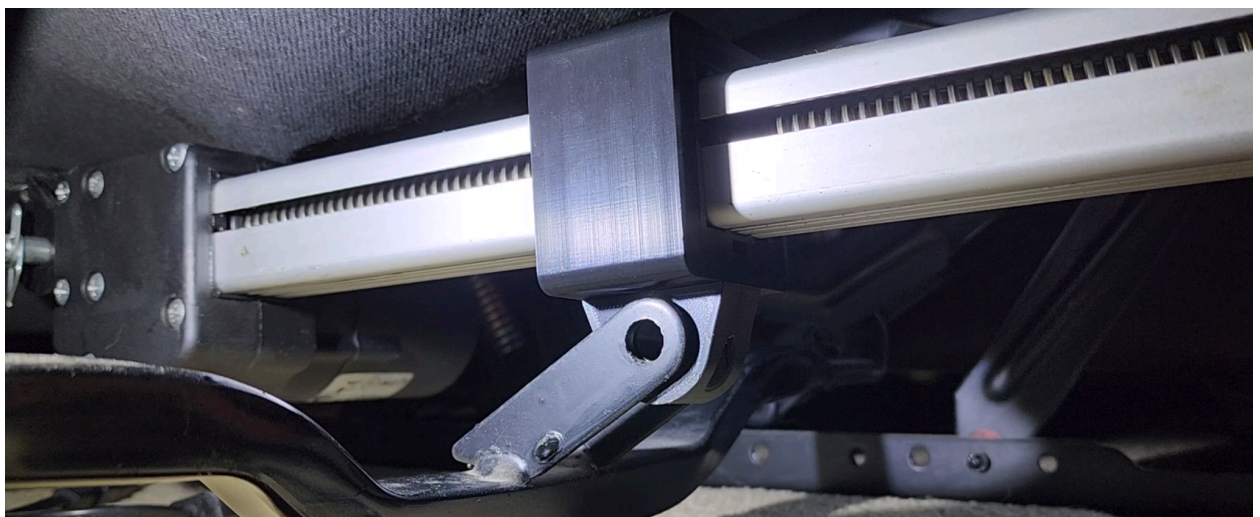
7. Plug the couch into the wall.
  - a. Due to the moving position of the recliner (assuming you are laying under it), the block will not line up with the couch recliner holes at all.
  - b. Use the recliner buttons to move the block to the correct position for inserting the main pin.
