Spring SRPT Linear Actuator Replacement Manual

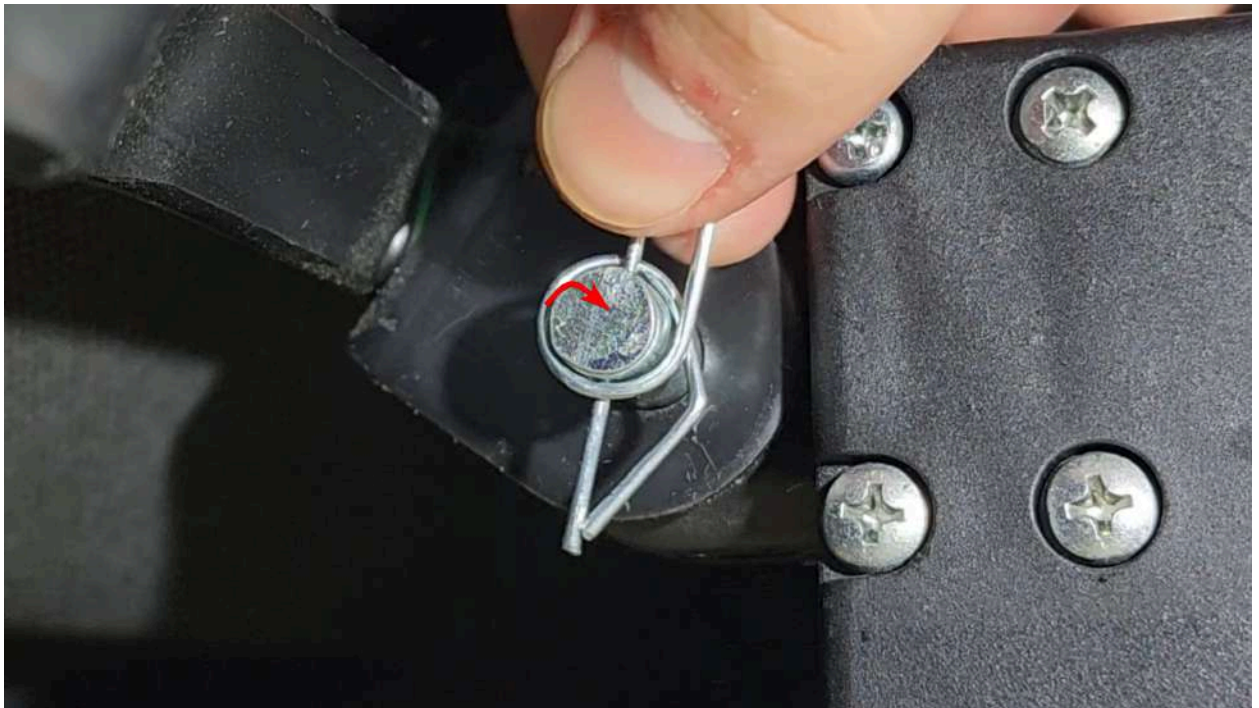
1. Before removing anything, make sure to press the button to move the recliner to the reclined position. Regardless of the chair not operating, this will help to remove the block later. Unplug the couch from the wall after this.
2. Ensure the 2 power cables are unplugged from the motor. There are small clips that hinge onto them to prevent them from coming loose. Undo the clips and unplug the two cables.
3. Undo the ring pin that is holding the main pin in place. This is best done by rotating it like this to slide the ring off the top of the main pin. Some couches may not have a cotter pin, so use your judgement to remove this main pin that holds the actuator in place.

4. Pull the retaining ring pin out of the chair.
5. Assuming the block is broken, the front one will not be attached to the motor assembly. The same steps apply to remove the retaining pin and main pin.
6. Remove assembly from the chair.

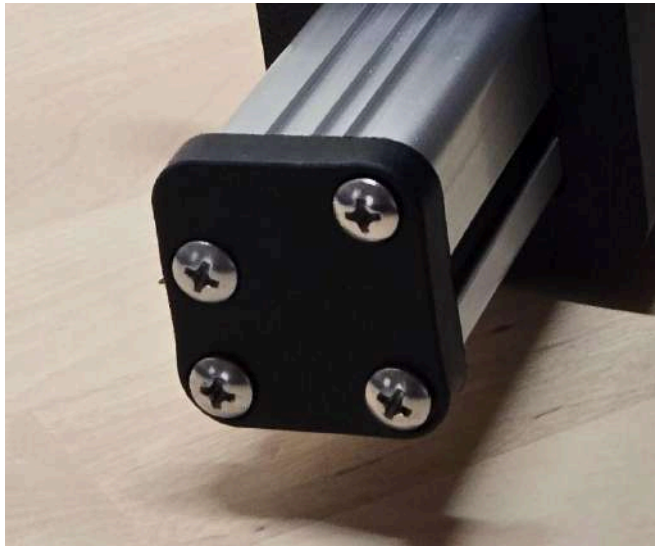
Remove the 4 small screws from the cap on the end of the assembly.

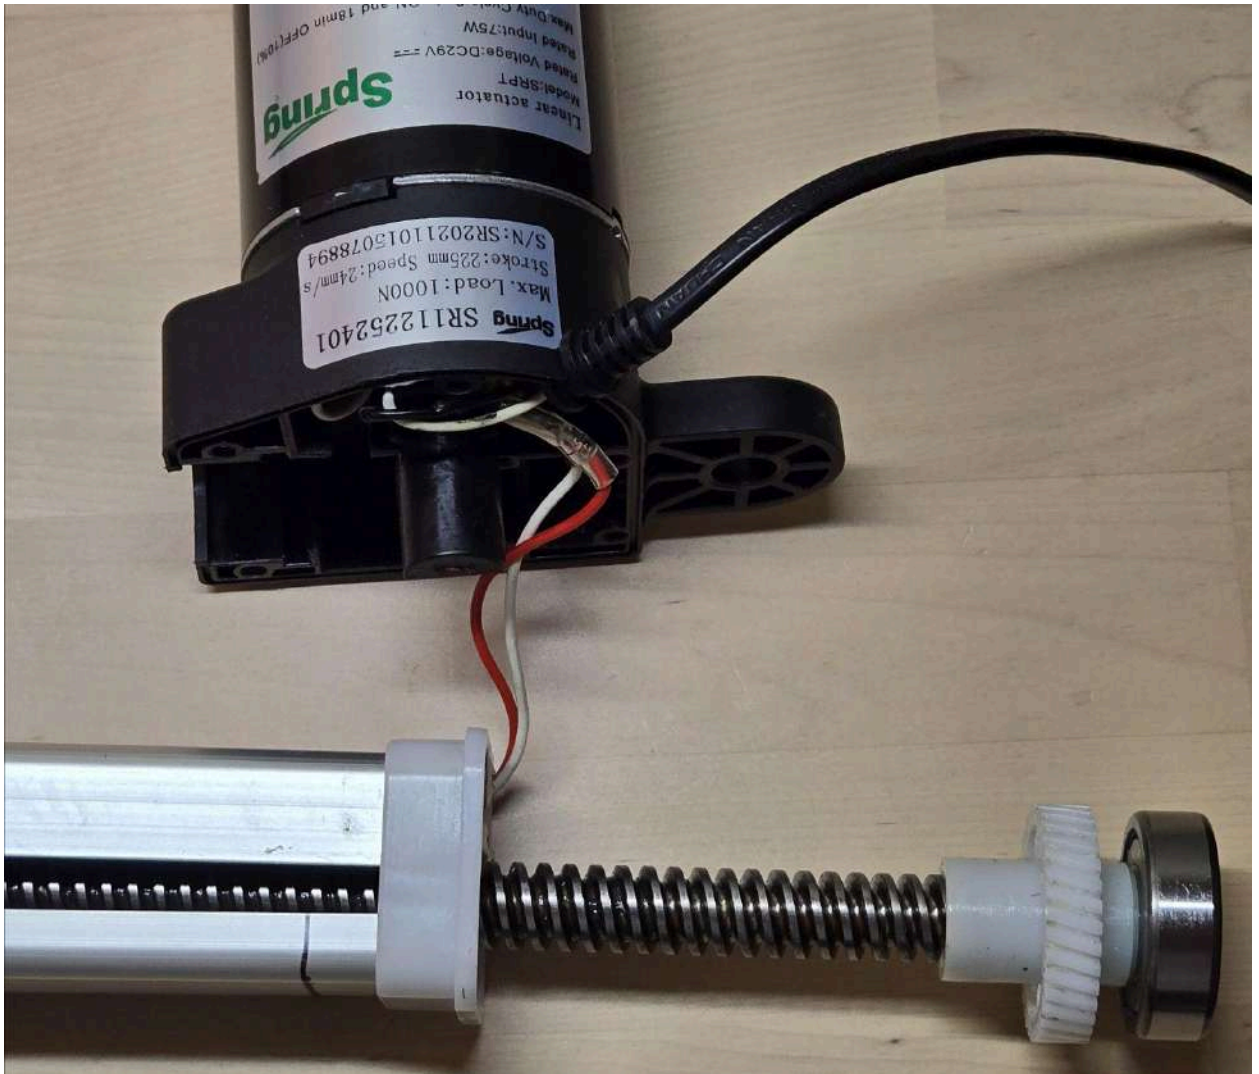
4. Rotate the plastic gear off of the worm gear. The wires do not need to be disconnected. Pulling the bottom of the plastic gear will rotate it off of the worm gear.

5. Twist the plastic gear counter-clockwise (the bearing pictured above is the top for reference) and either 2 things will happen
- The broken plastic block will slide to the end of the aluminum rail and you can take it off.
 - The lead screw comes out and the plastic block doesn't move. If this happens keep going in the same direction, then push the lead screw down back into the aluminum rail. This will push the plastic block off the end. Repeat as many times as necessary to remove the block.

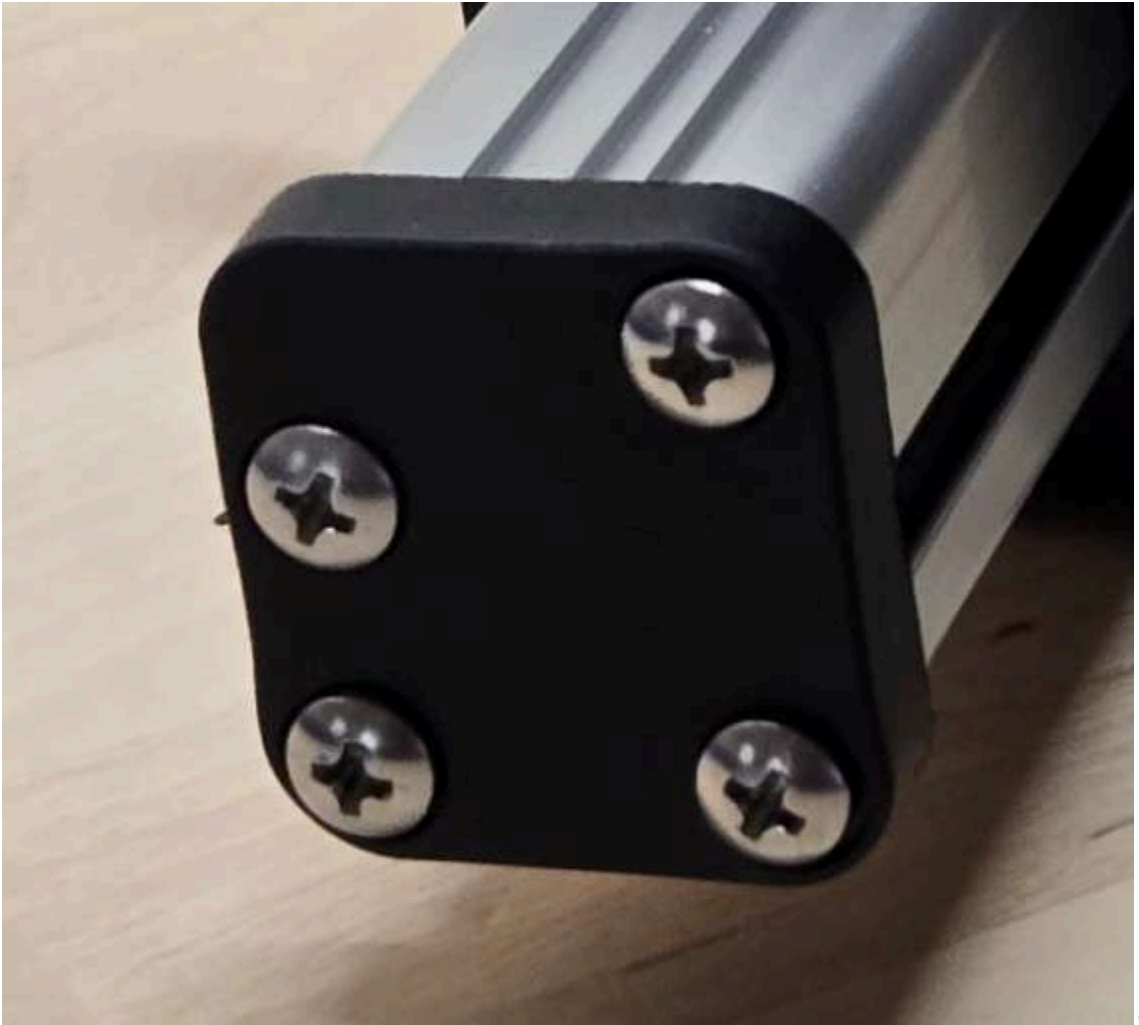
15. Reattach the cap at the end of the aluminum rail.

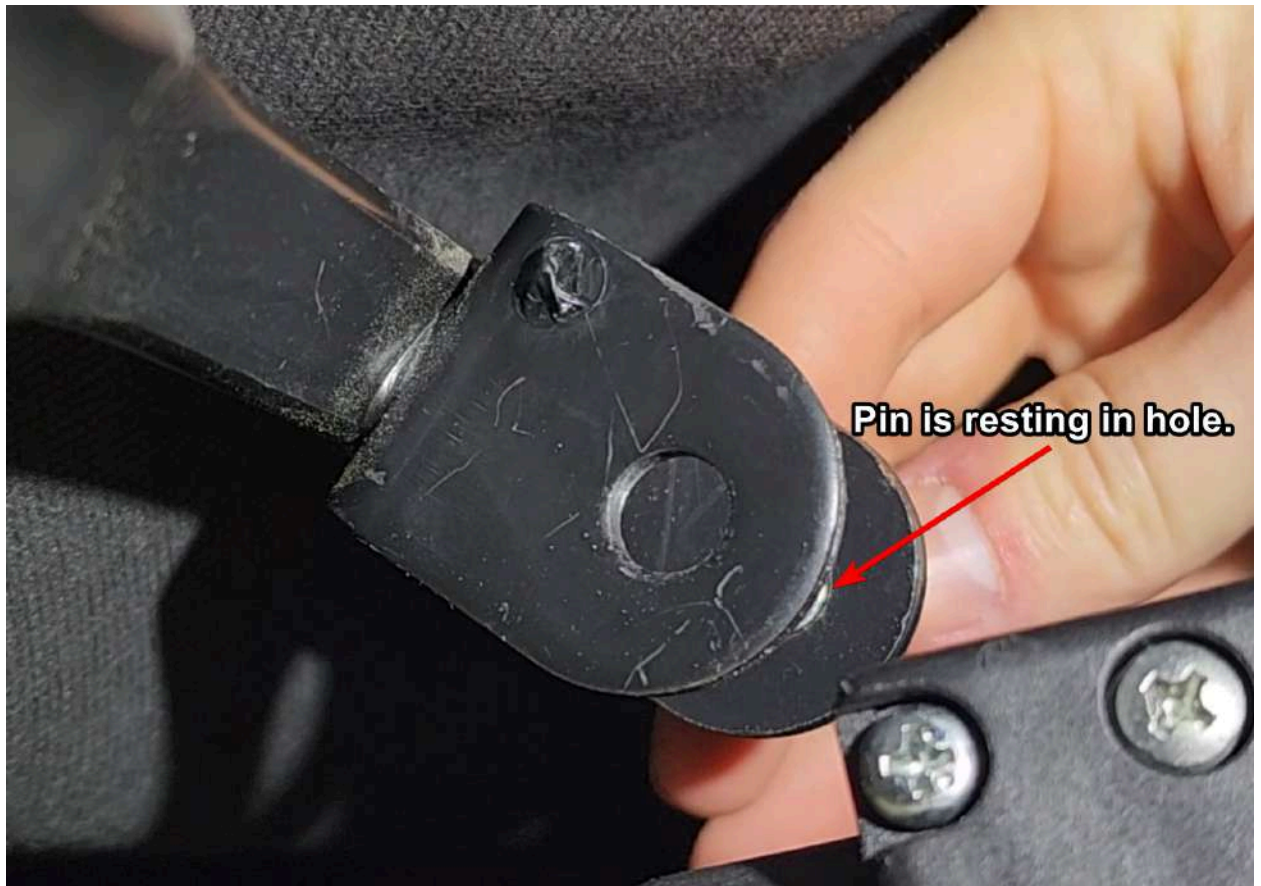
1. Before attaching either of the pins, the couch should still be unplugged from the wall.
2. Plug the two couch cables back into the motor.
3. Start with the rear pin, where the motor is. I found that resting the pin in the hole very shallowly helped with getting it through the two plates and assembly.

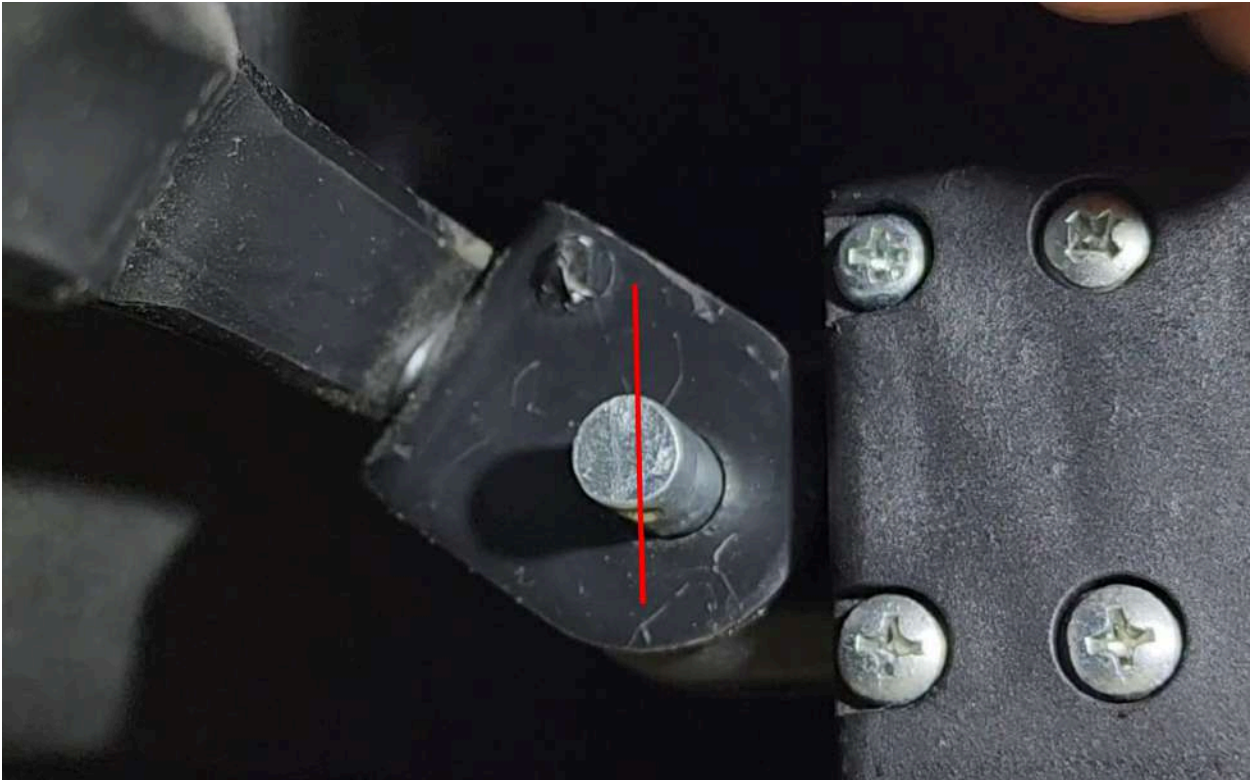
4. Make sure the hole in the main pin is roughly up/down so that the retaining ring pin can be pushed in easily.

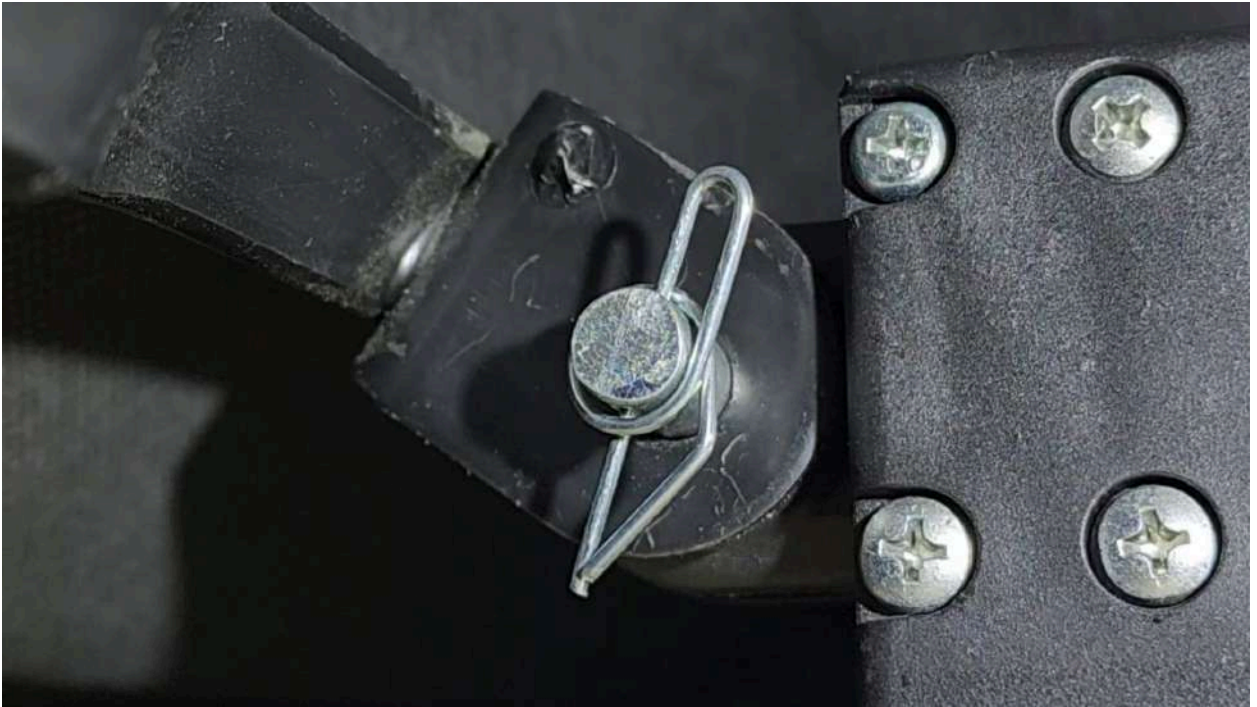
6. Twist the retaining ring pin so that the ring snaps into the locked position on the main pin. It should look like this when complete.

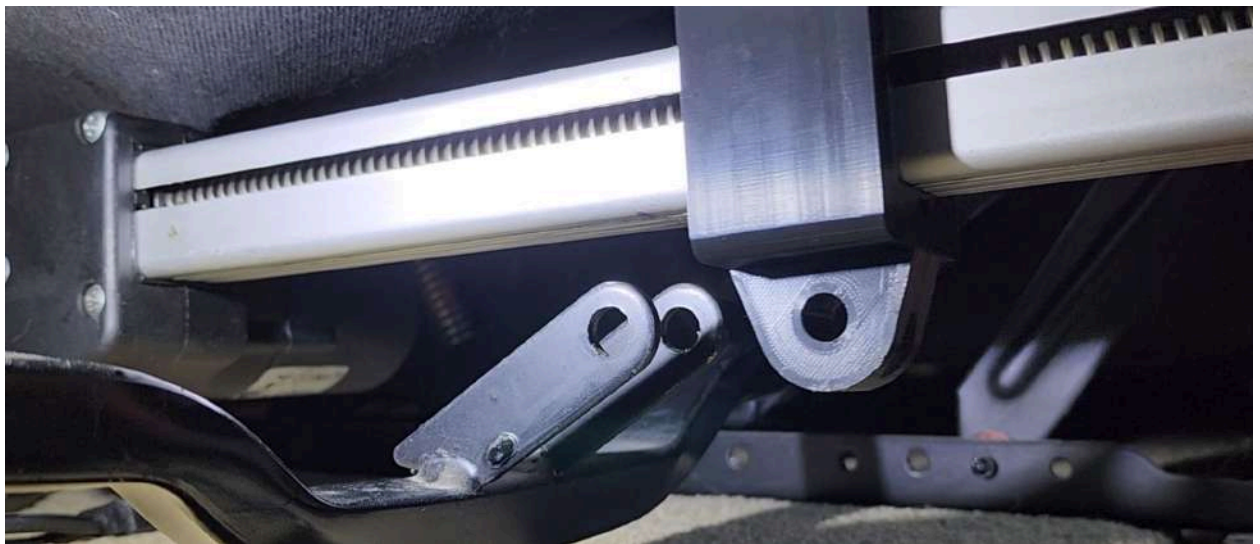
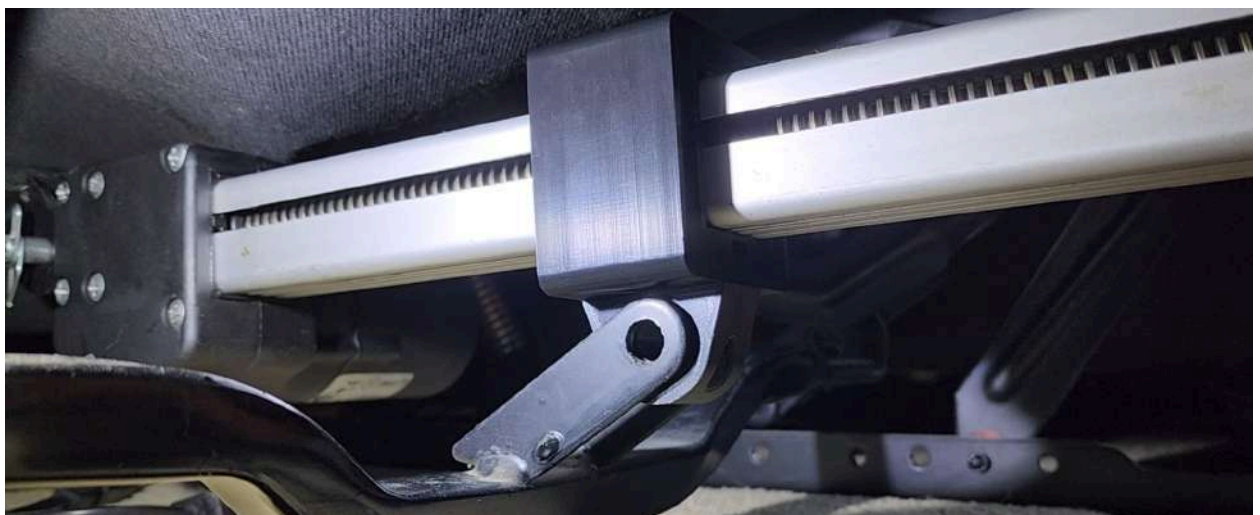
7. Plug the couch into the wall.
 - a. Due to the moving position of the recliner (assuming you are laying under it), the block will not line up with the couch recliner holes at all.
 - b. Use the recliner buttons to move the block to the correct position for inserting the main pin.

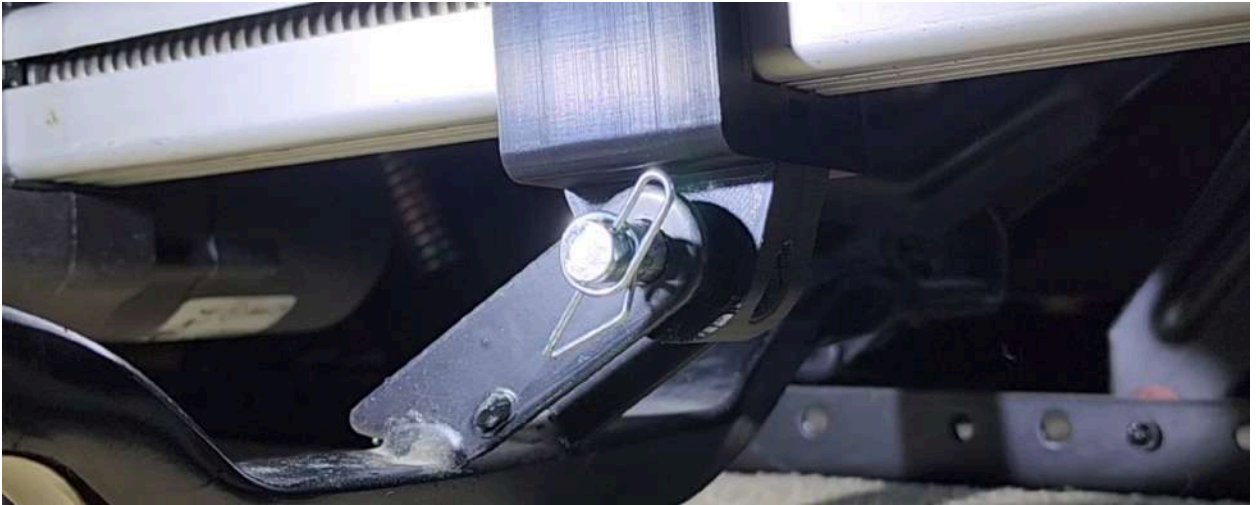
8. Repeat the same insertion steps as the back main pin.
